Arboricultural site appraisal for the proposed residential
development of Owenmore Crescent, Collooney, Co Sligo.

Drew Bardell Dip Arb L4 'Tech Arbor A'.
Beith Tree Consultancy
www.beithtreeconsultancy.ie

Tuesday 1st October 2024

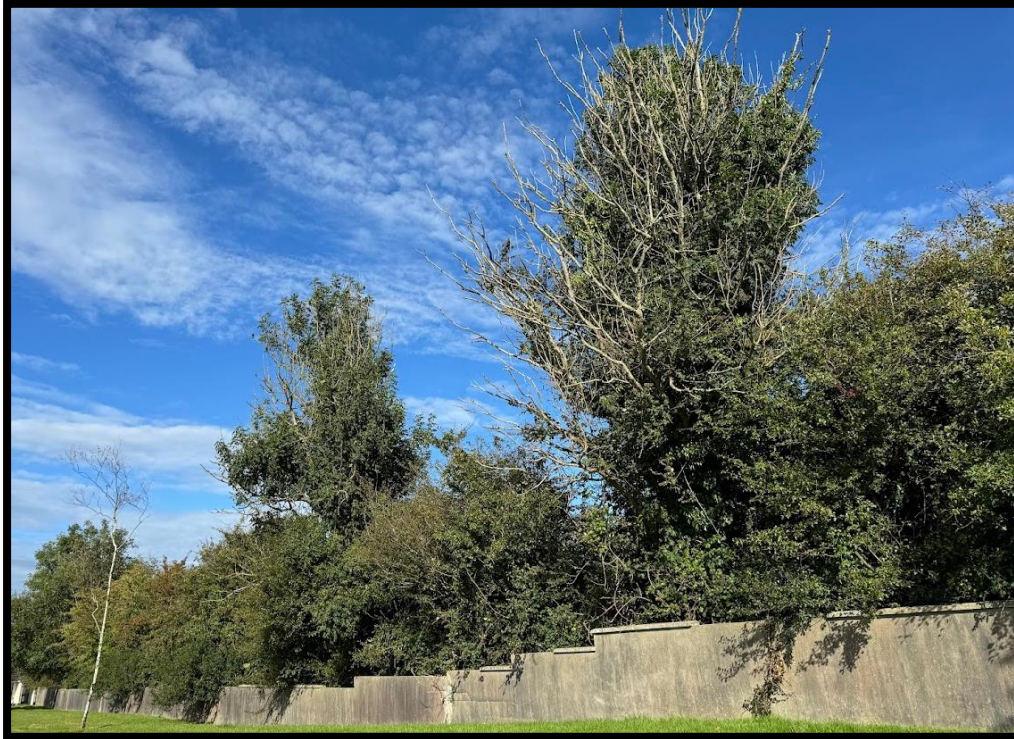
Image of the southern boundary looking west along River Walk. Tag 368 & T369 in view.

To the north of the southern boundary is a linear feature that consists of a dense unmaintained native hedgerow of mixed species with sporadic mature Ash trees (*Fraxinus excelsior*) this feature spans the full length of the southern boundary. The species mix is whitethorn (*Crataegus monogyna*), blackthorn (*Prunus spinosa*), Elderberry (*Sambucus nigra*) and a young sycamore (*Acer pseudoplatanus*). Dense briars prevent access to the hedgerow and are approximately 2m in height. Ivy covers the main stems and is growing into the crowns of both the trees and hedgerow plants.

A block wall with concrete capping's provides the southern boundary of the site. See image above. This wall is approximately 1.1m in height and begins at the gate on Church View and spans along River Walk as far as House No 34. To the south of this wall is approximately 8m of maintained grass with the street scape of River Walk beyond.

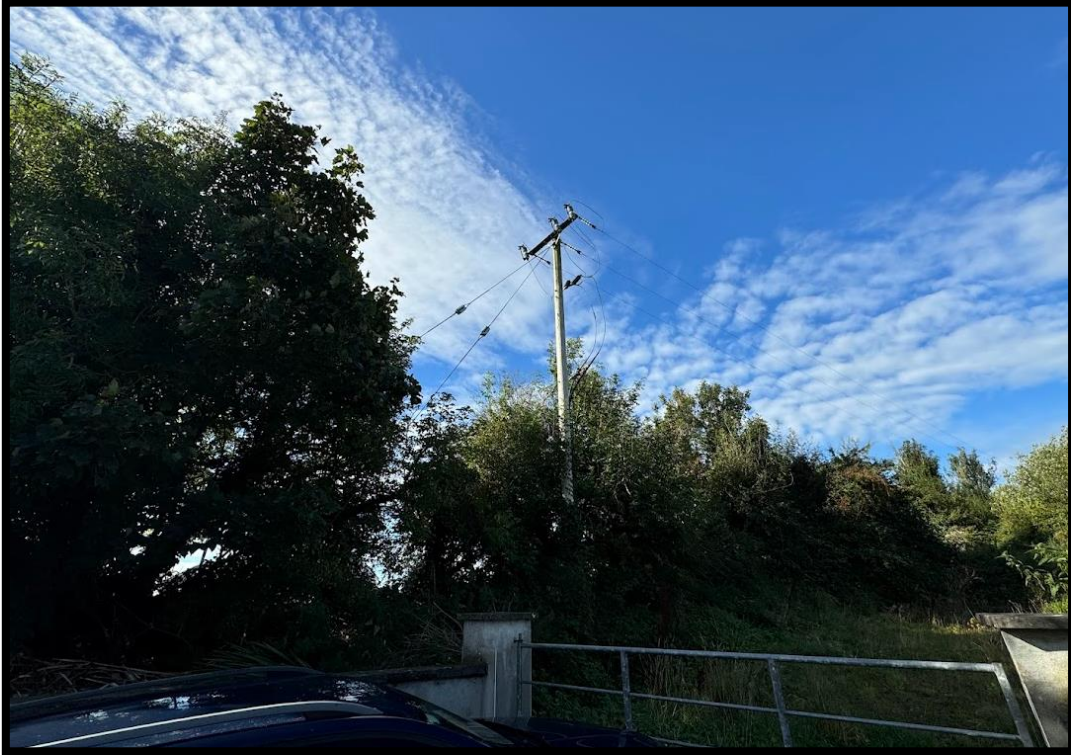
Travelling just inside the hedgerow is an E.S.B 3 phase electricity overhead powerline. It begins at the southeastern corner of the site from an underground connection and stretches halfway along the southern boundary before turning northwest, crossing through the site and exiting on the far northwest corner.

Image of the southeast corner of the site, looking southwest. ESB network present.

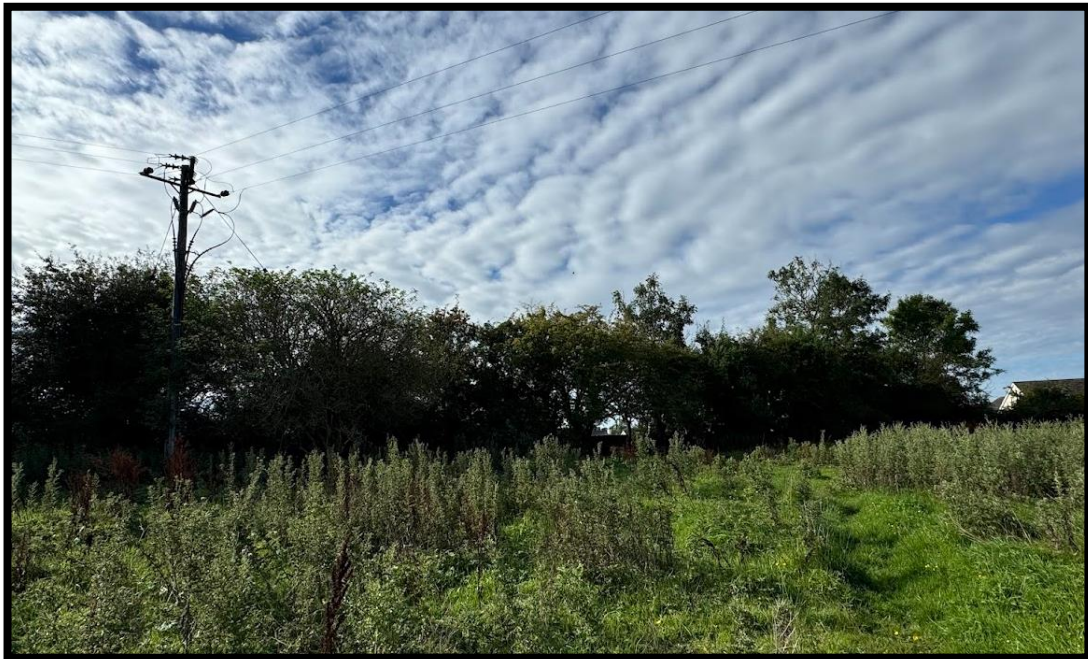
Image halfway along the southern boundary looking south. ESB network turning northwest.

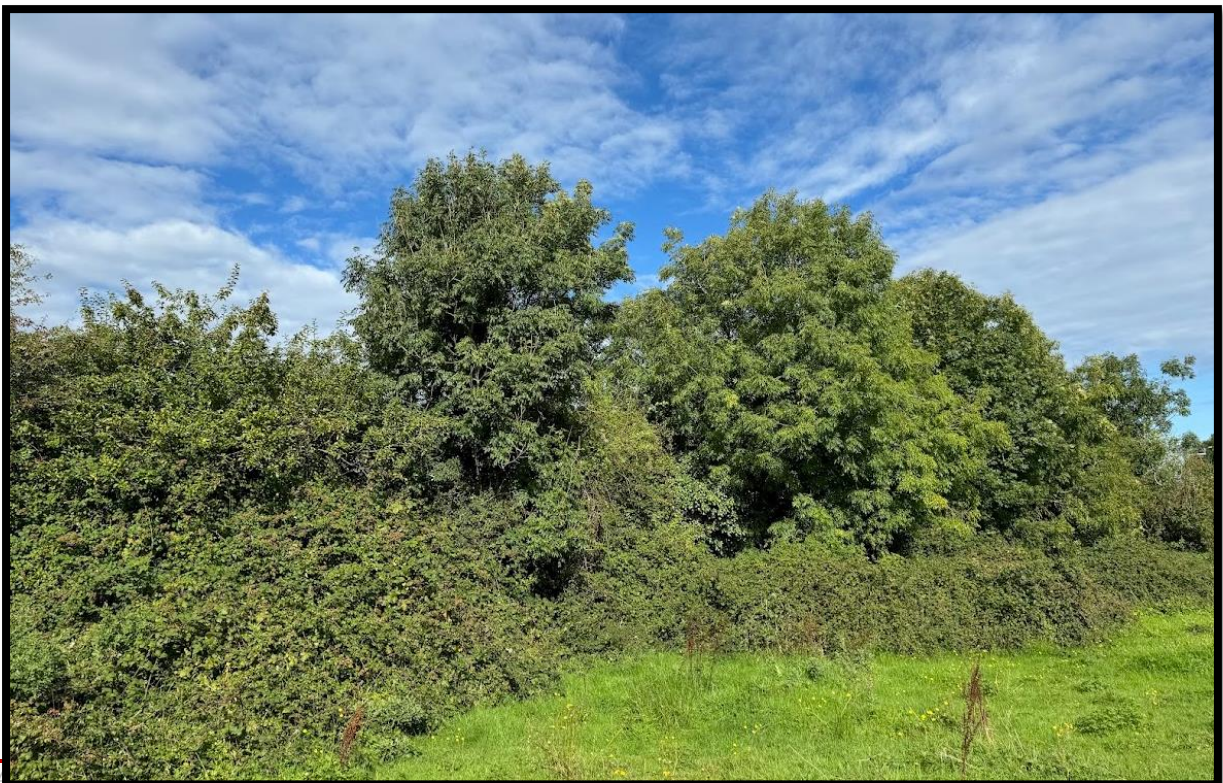
The boundary consists of a dense unmaintained native hedgerow of mixed species with sporadic mature Ash trees (*Fraxinus excelsior*). The species mix is whitethorn (*Crataegus monogyna*), blackthorn (*Prunus spinosa*), Elderberry (*Sambucus nigra*) Holly (*Ilex aquifolium*) and Crab apple (*Malus sylvestris*).

Dense briars prevent access to the trees/hedgerow from the eastern aspect. See photo below. However, the stems of most of the trees were accessed via a track along the boundary ditch. The western boundary is also aligned by the block wall and capping stones of the properties of River Walk.

View of the western boundary, bordering house numbers 34-39 River Walk from inside the site looking west.

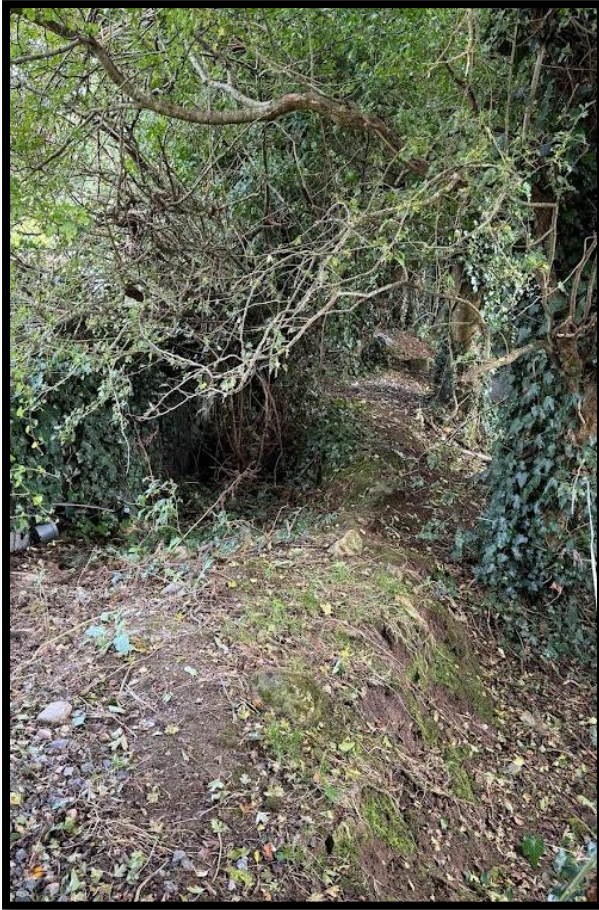
Boundary ditch at rear of 34-39 River Walk.

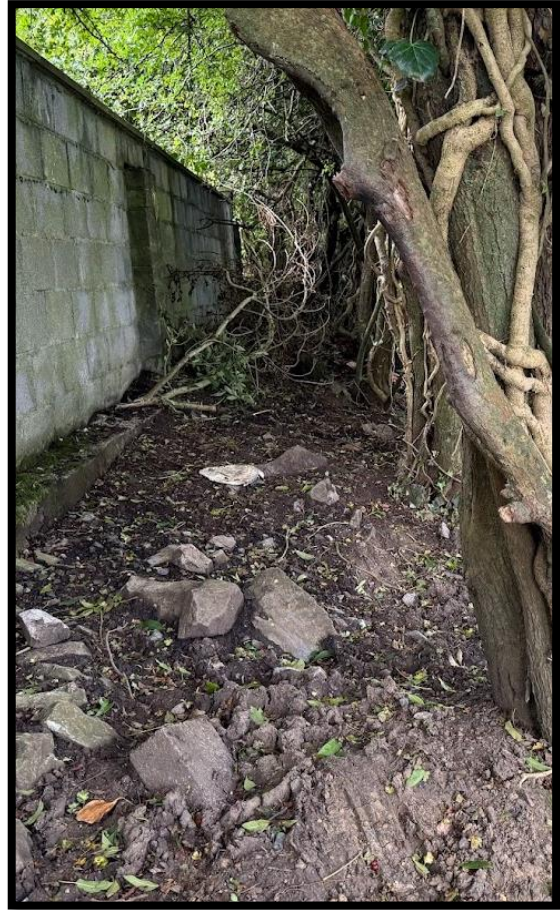
Northern aspect outside house 39 River Walk.

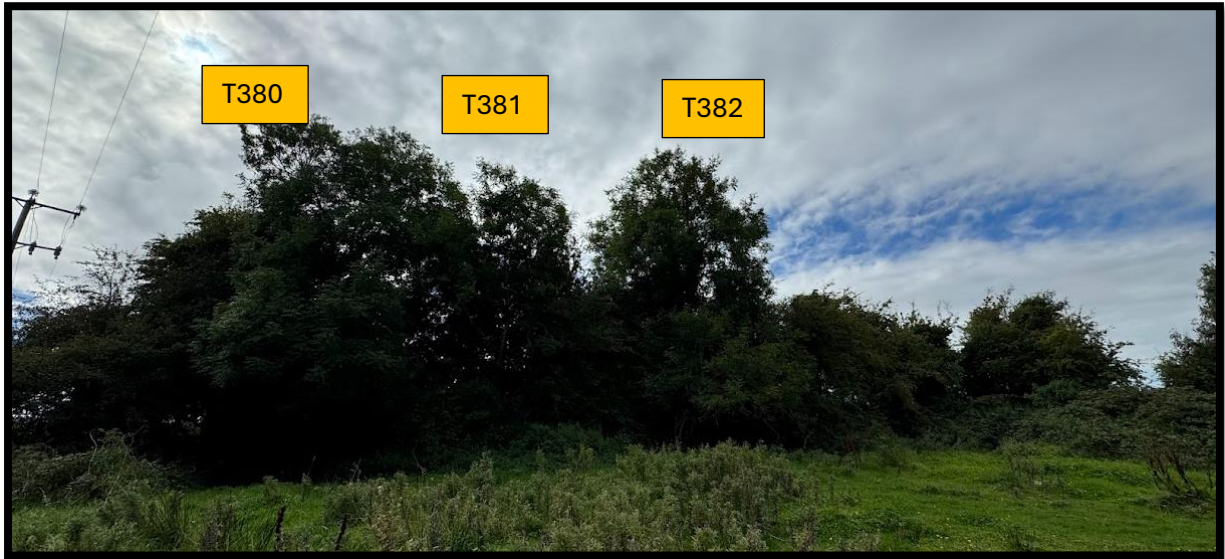
Tags 380, 381 and 382 located along the boundary of house 39 River Walk.

Tree No.	Species	Tree Height (m)	Stem dia (mm)	Crown spread (m)				Height & Direction of 1 st Branch (mm)	Min. Crown Clearance (m)				Life stage	Physiological condition	Structural condition/ Preliminary management recommendations	Remaining contribution	Retention category	RPA R (m)
				N	E	S	W		N	E	S	W						
380	Ash	15m	318 222	6	3	4	3	West 4m	4	6	3	6	M	Fair	Multi stemmed from ground level with included union. Central stem is dead 2m in length. Southern stem has a lean into garden of No39 River Walk. 1m drop in ground level north of main stem.	10+	B,1	4.8m
381	Ash	13m	232	3	3	3	2.5	North 5m	5	6	7	6	M	Fair	Crown bias and heavy lean to the north. Main stem growing out from the side of the ditch.	10+	C,1	2.7m
382	Ash	15m	308 366	4	3	3	2.5	North 3m	5	5	3	5	M	Fair	Basal stem cavity to the southwest aspect probed beyond 460mm. Co dominant stems above 600mm. Main stem is 1.3m above ground level to the north.	10+	C,1	5.7m

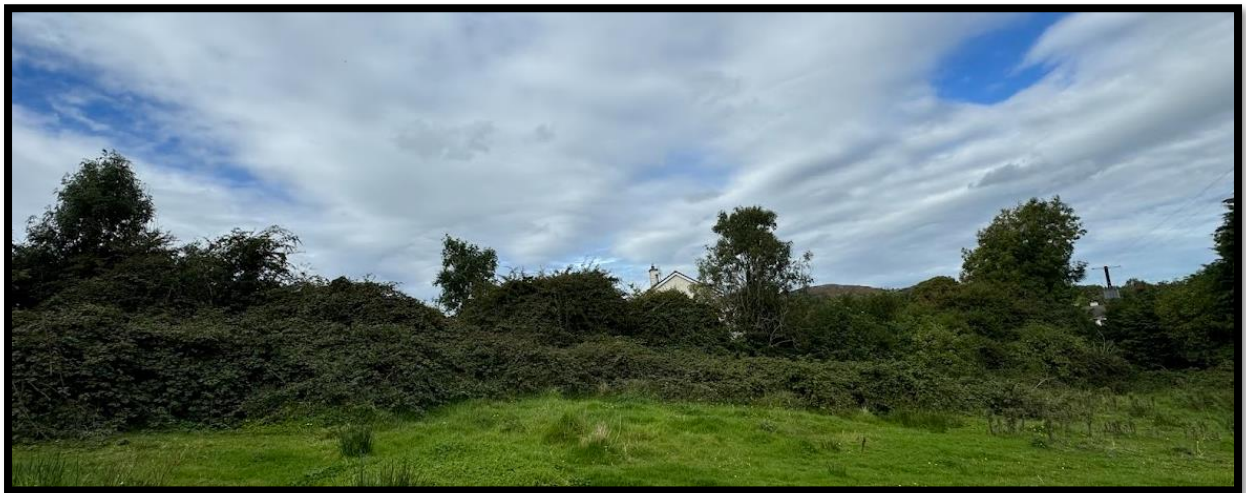
Western boundary bordering houses 40 -41 River Walk.

This section of the boundary was inaccessible due to the dense vegetation, briers approximately 10m wide to the eastern aspect of the site boundary. The hedgerow is unmaintained and predominantly whitethorn (*Crataegus monogyna*), blackthorn (*Prunus spinosa*), Elderberry (*Sambucus nigra*) with two mature Ash trees (*Fraxinus excelsior*).

The hedgerow, H04 was classified as trees of low quality. Category C,2 (as per Table 1 of BS5837:2012)

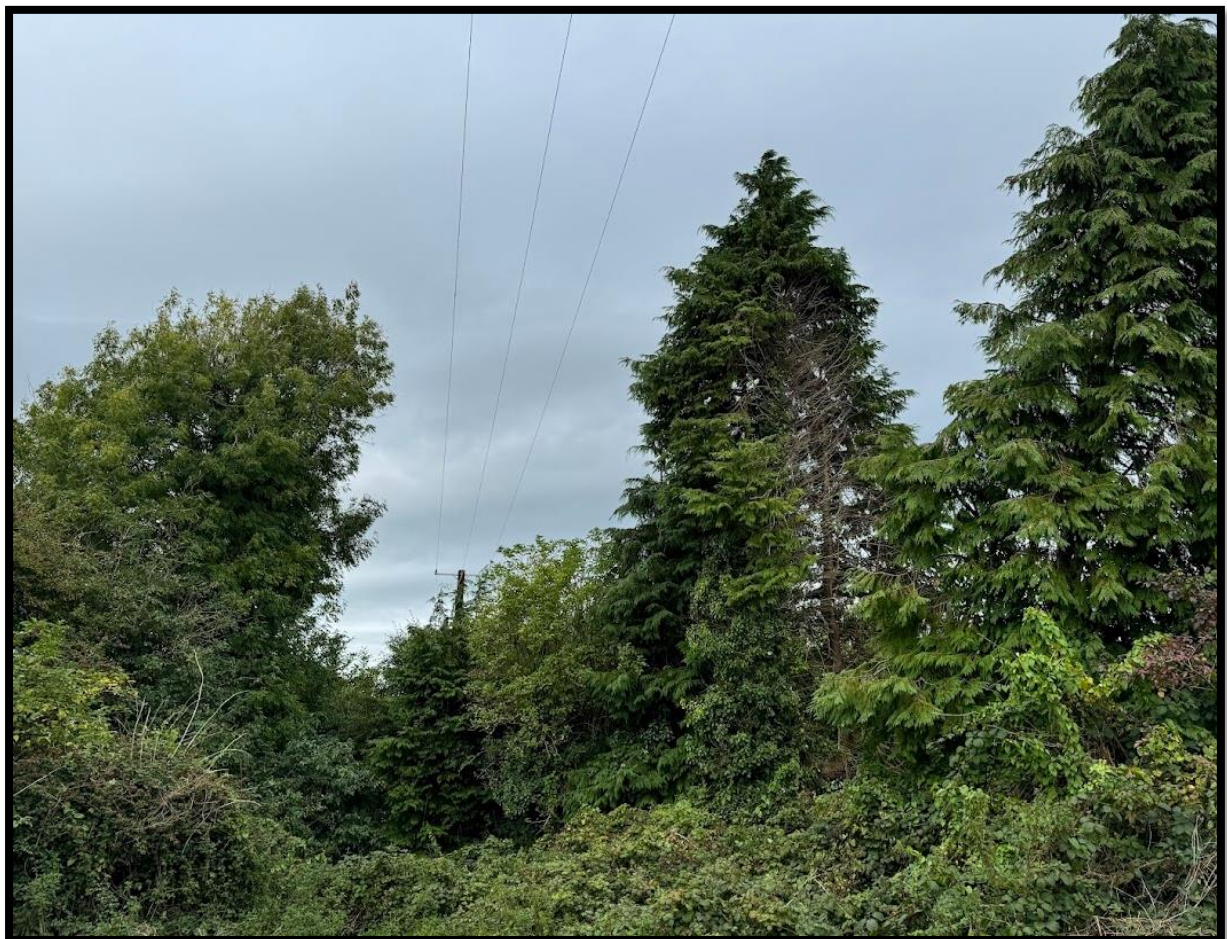
At the sites most northerly point there are some Lawson cypress (*Chamaecyparis lawsonia*), however these trees could not be accessed on the day due to dense vegetation and may possibly be in a private garden on the far side of the boundary. The trees are also in close proximity to the E.S.B. overhead powerline that exits the site at this point. See photo below.

Lawson cypress trees at the most northerly point of the site.

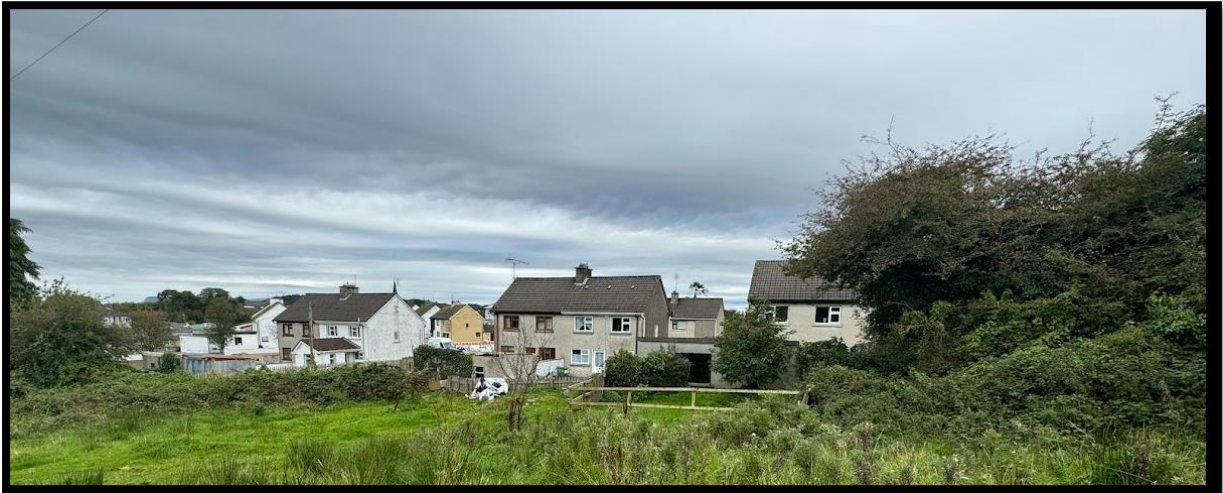
Approximately 16m of the northern boundary with no hedgerow, bordering houses of Kiernan Avenue.

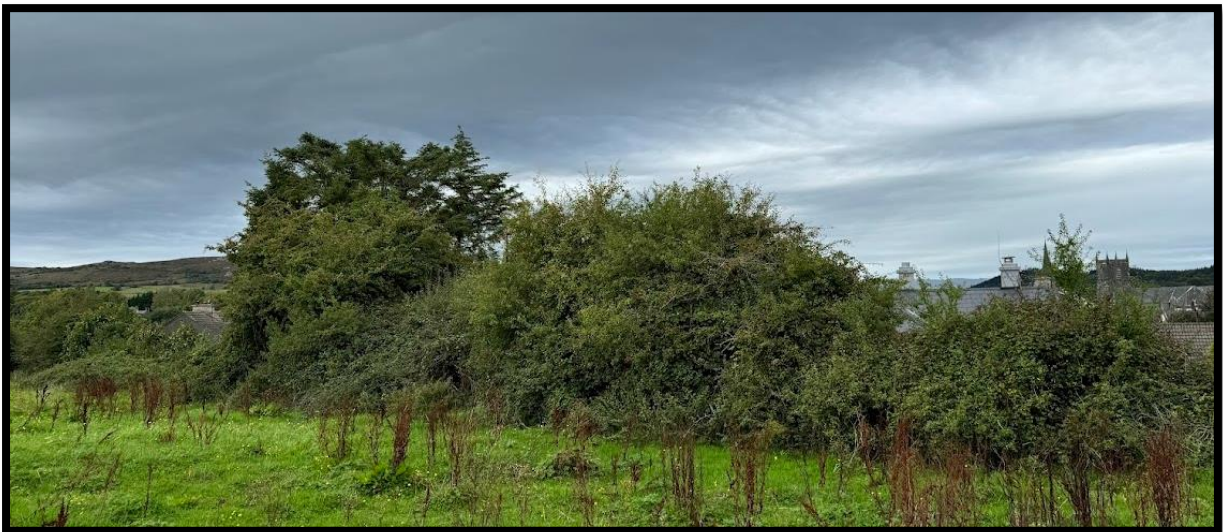
Some taller spruce trees on the northern boundary that are in the neighbouring property have been reduced in height.

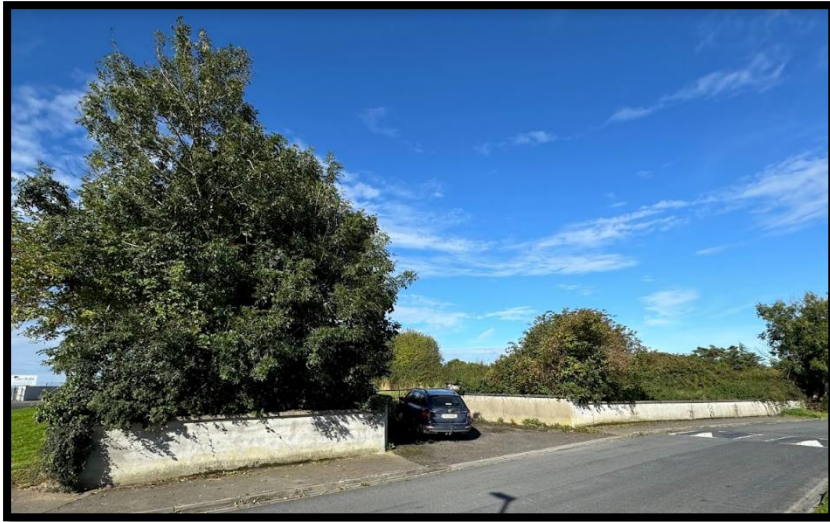
The eastern boundary aligns the road of Church View. A large portion of this boundary is taken in with the old reservoir that is now covered in dense vegetation and inaccessible. A block wall with concrete capping's surrounds this feature. See photo below.

Block wall enclosing the old reservoir.

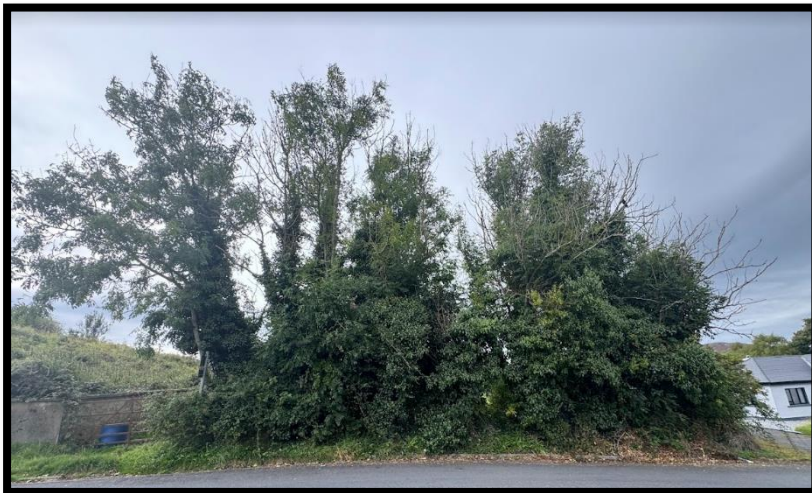
In the northeast corner of the site is a group of 9 Ash trees. Ash dieback is very prevalent in this group and some of the trees are dead. Dense Ivy covers the main stems and into the upper canopy and there are briars up to 2m in height at the base of the trees. The understorey for the group is whitethorn (*Crataegus monogyna*), blackthorn (*Prunus spinosa*).

The group of Ash trees in this feature were classified as trees unsuitable for retention. Category U (as per Table 1 of BS5837:2012)

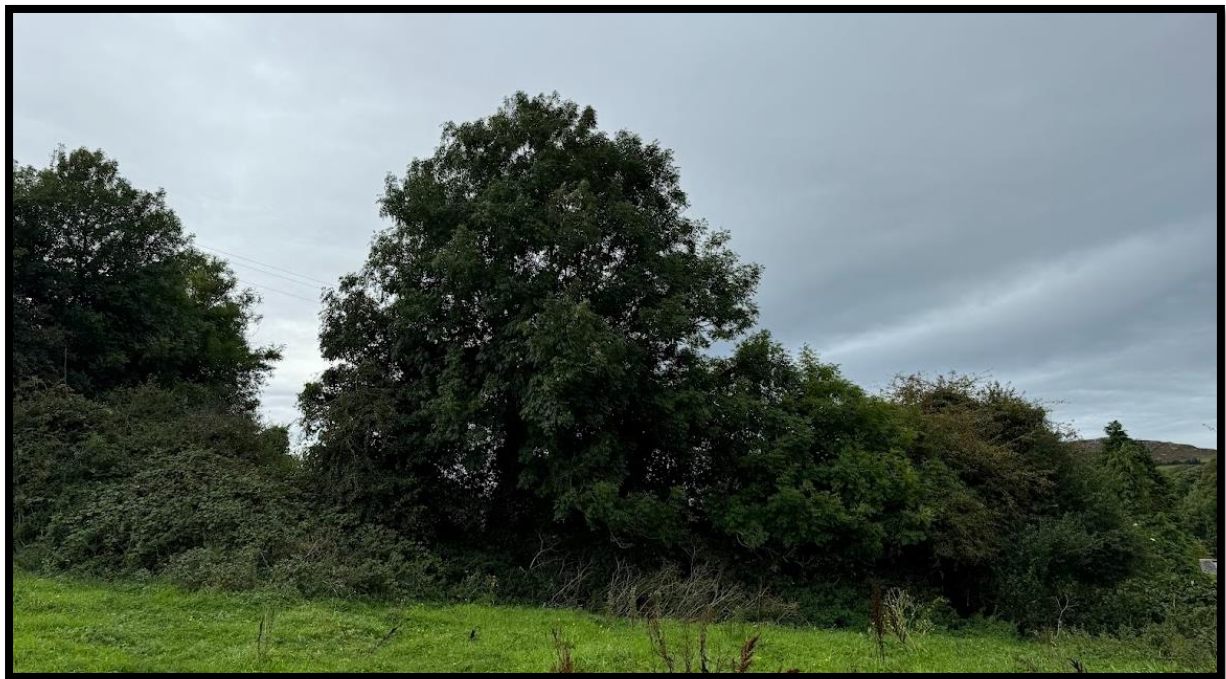
This feature crosses the site at its narrowest point, from the corner of the western boundary at the block wall of house 39 River Walk to the northern boundary. Dense nettles and briars spreading out from the hedgerow upto 2m in height around the trees prevent access to the two mature Ash (*Fraxinus excelsior*). The under storey is dominated by whitethorn (*Crataegus monogyna*).

The Ash tree was classified as a trees of moderate quality Category B,1 (as per Table 1 of BS5837:2012).

The hedgerow, H06, in this feature was classified as trees of low quality. Category C,2 (as per Table 1 of BS5837:2012)

View of internal hedgerow looking west.
