## SOCIAL HOUSING DEVELOPMENT

### RATHELLEN HOUSE, FINISKLIN, SLIGO

#### Refurbishment Asbestos Survey Report

SHB3-FIN-CS-RPS-RP-RP010

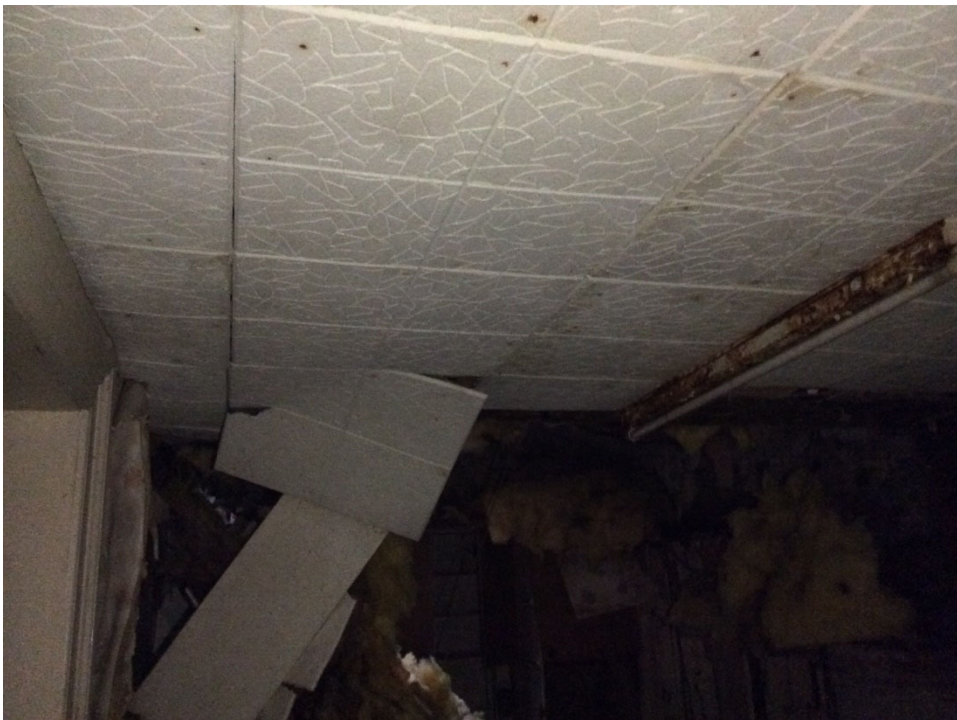
### 3.2.1 Sample Ref. RH01

<b>Location of Material</b>	Ground floor kitchen to the west end of the building	<b>Laboratory Ref. / Site Ref.</b>	FSB20210610.01 RH01
<b>Similar material</b>	N/A		
<b>Asbestos Identified</b>	No		
<b>Product Type</b>	FSB20210610.01/ RH01 – Ceiling tile		
<b>Action</b>	No action required.		
<b>Photo</b>

- FSB20210610.01 – Ceiling tile from kitchen to west end – No asbestos detected.
- FSB20220128.01 – Floor tile and adhesive from kitchen to west end – Asbestos found in the chrysotile form.

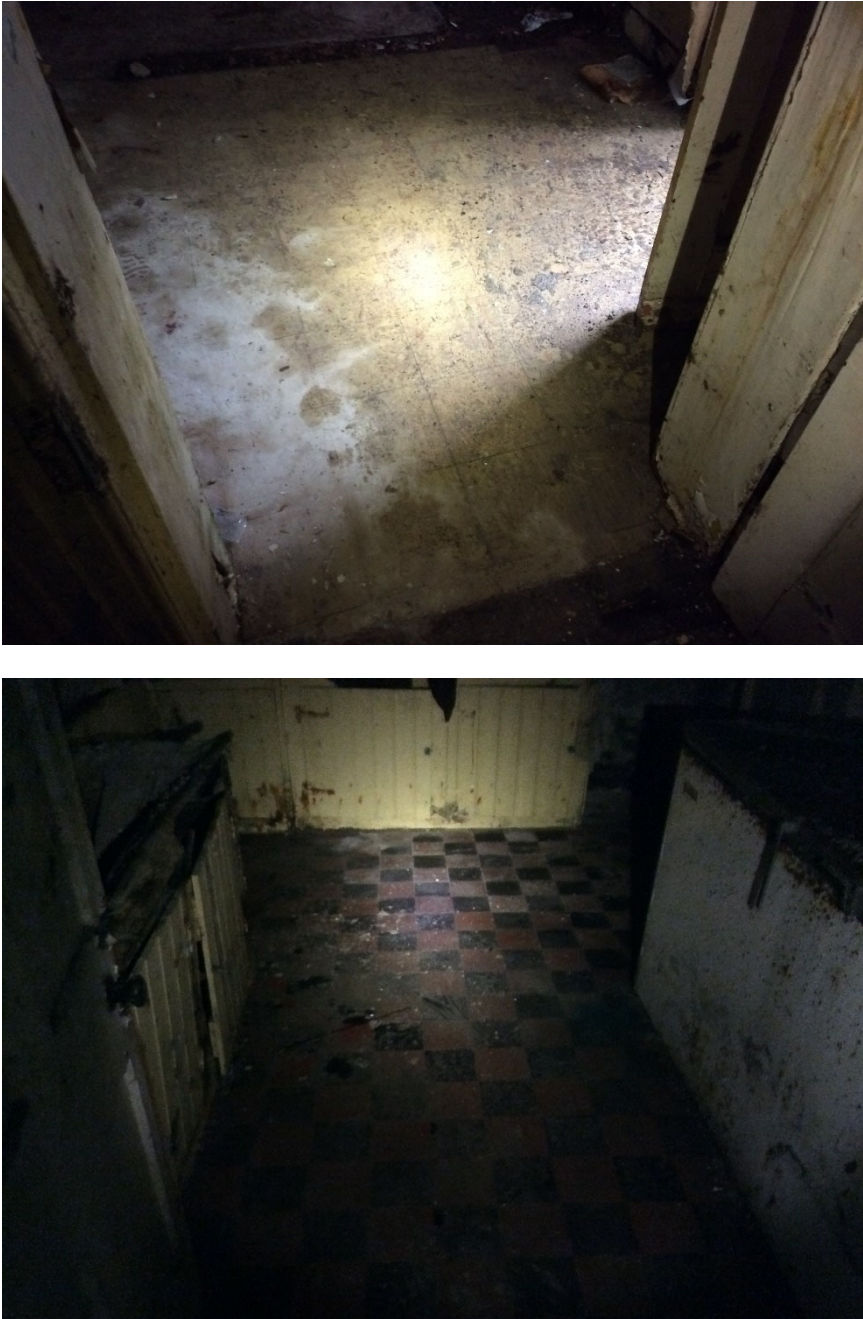
## 3.2.2 Sample Ref. RH02

<b>Location of Material</b>	Ground floor kitchen to the west end of the building	<b>Laboratory Ref. / Site Ref.</b>	FSB20220128.01 RH02
<b>Similar material</b>	All areas where floor tiles and adhesive are found in the building		
<b>Asbestos Identified</b>	Yes – chrysotile in the tile and adhesive		
<b>Product Type</b>	Floor tile and bitumen adhesive		
<b>Action</b>	These materials must be removed prior to works causing disturbance.		
<b>Photo</b>

Area Surveyed	Sample Number	Location and Use of Material	Asbestos Type	Condition	Material Assessment.	Recommended Action.	Priority Assessment.
Rathellen House	FSB20210610.01 / RH01	Kitchen – Ceiling tile	NAD	No Asbestos Detected (NAD)			
Rathellen House	FSB20220128.01 / RH02	Kitchen – Floor tile & adhesive	Chrysotile	Good	3	Remove prior to works causing disturbance	4

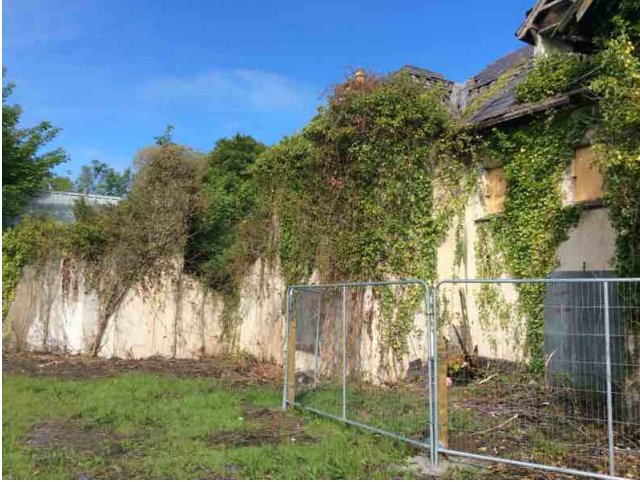
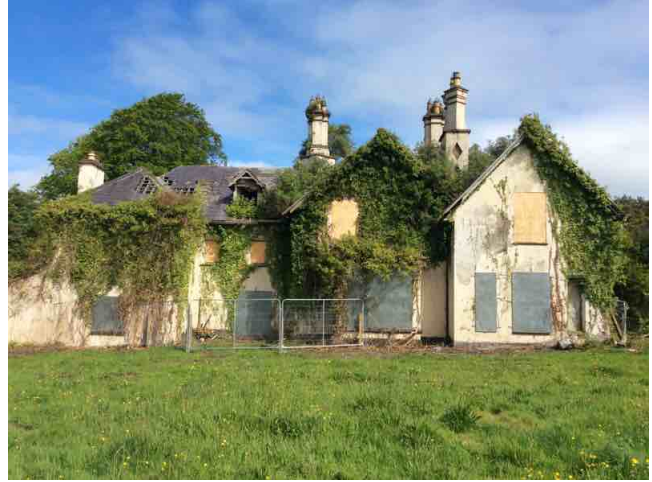
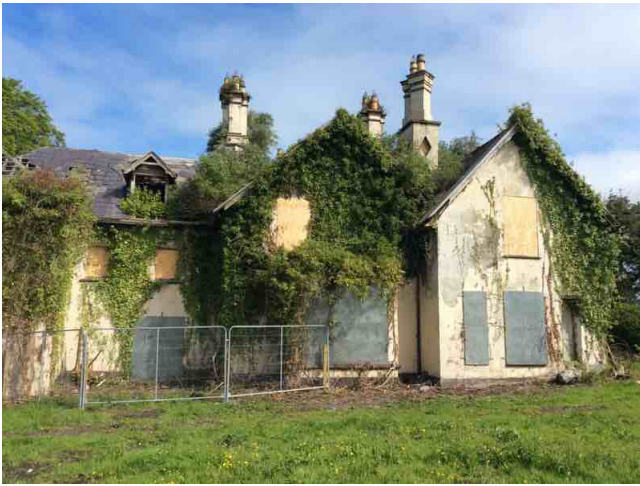
17 08/06/2021

Photographic record of southern elevation. No suspect asbestos containing material found.

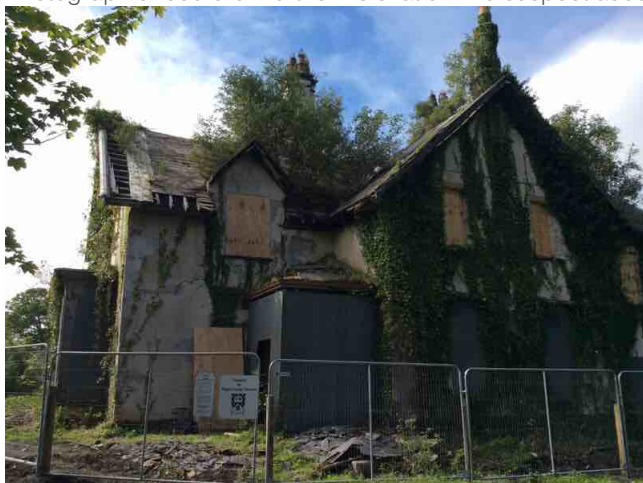
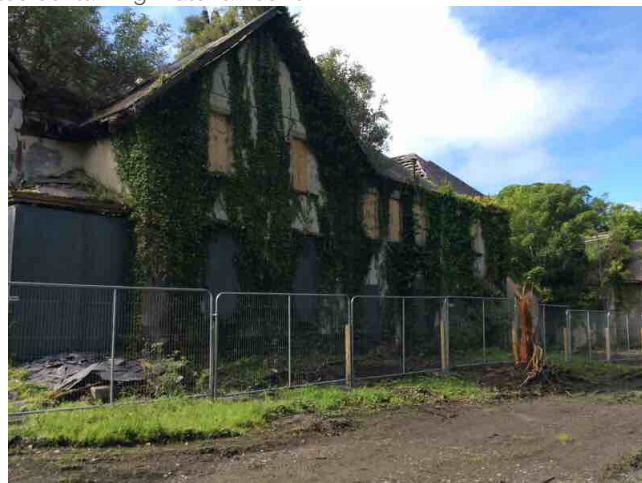
19 08/06/2021

Photographic record of northern elevation. No suspect asbestos containing material found.

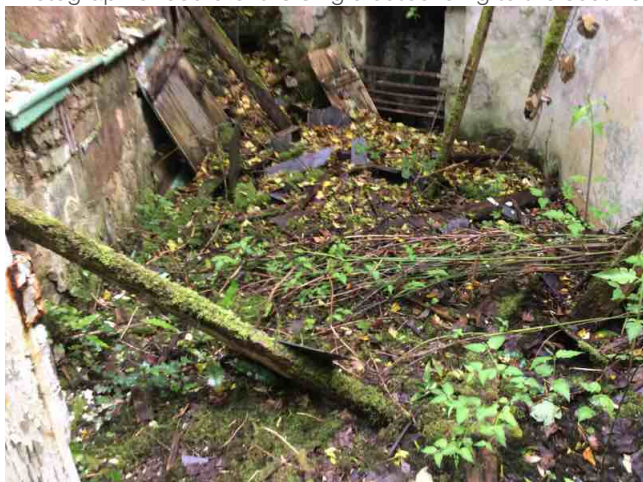
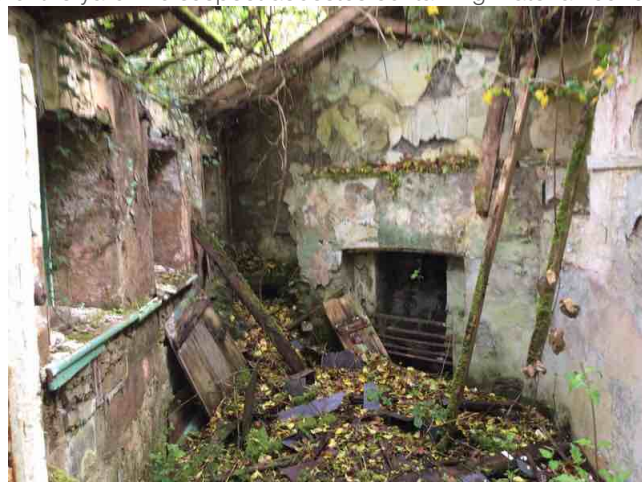
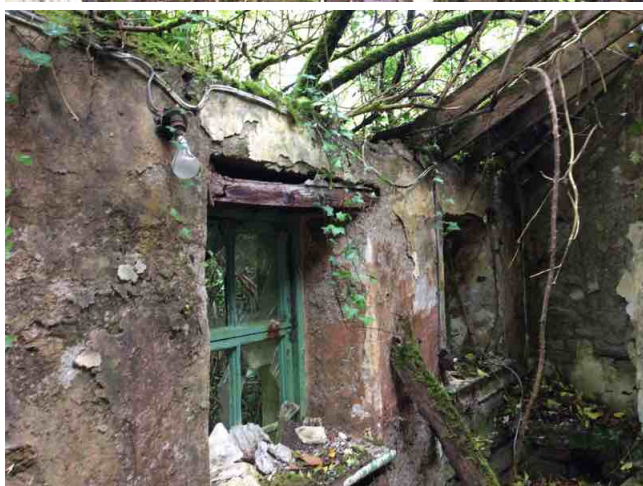
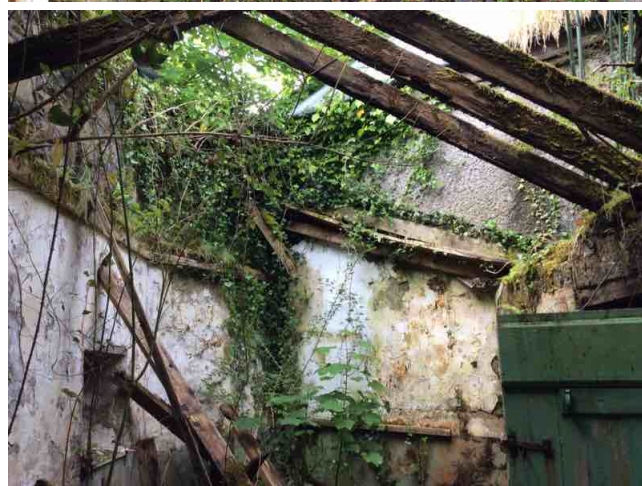
20 08/06/2021

Photographic record of the single outbuilding to the south end of the yard. No suspect asbestos containing material found.

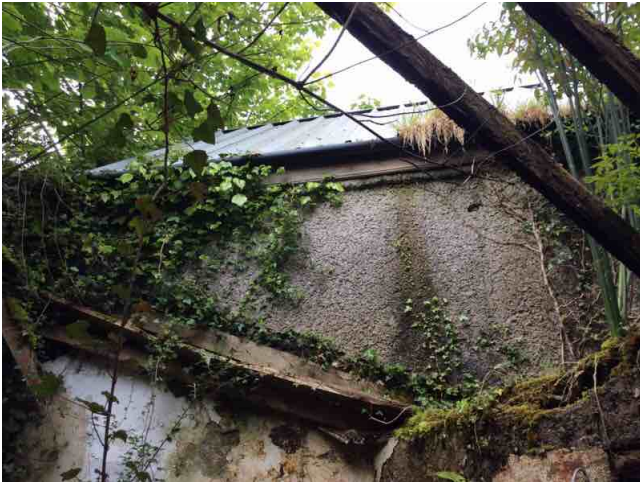
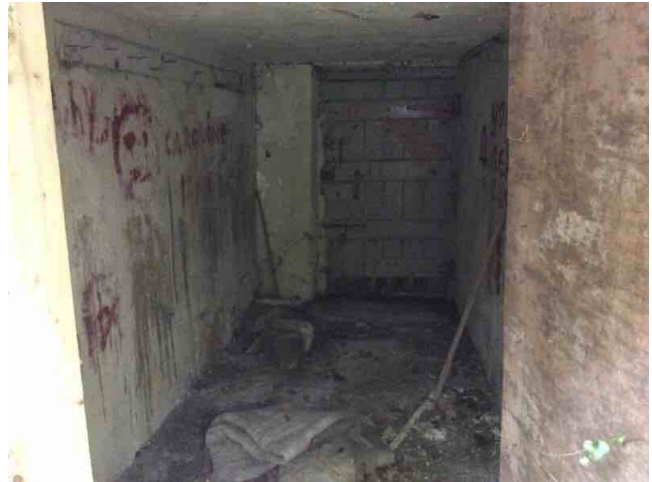
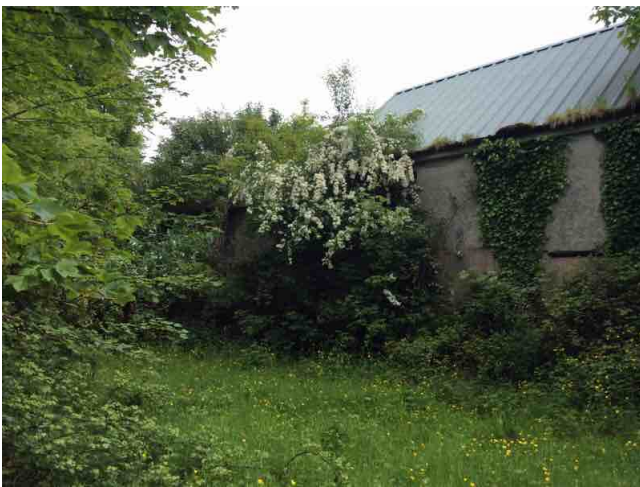
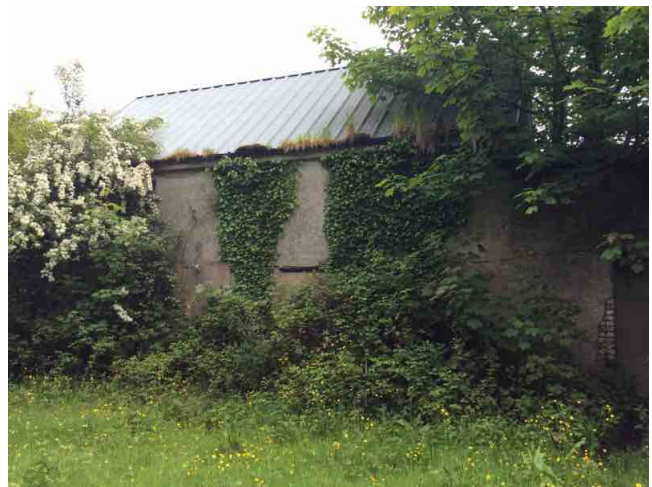
21 + 08/06/2021

Photographic record of the section of outbuilding with a modern steel corrugated roof. No suspect asbestos containing material found.

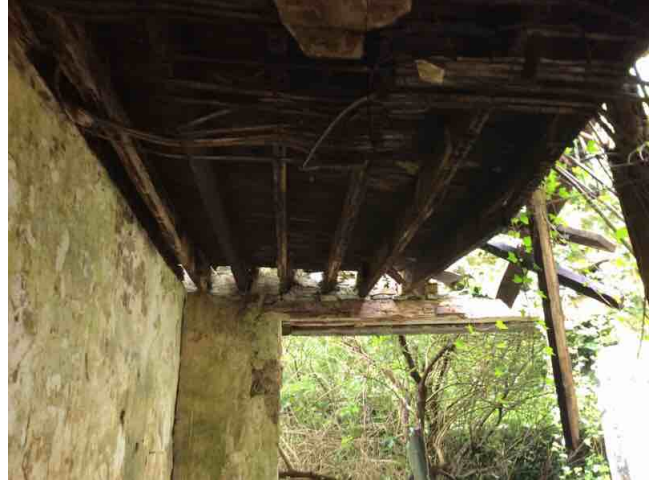
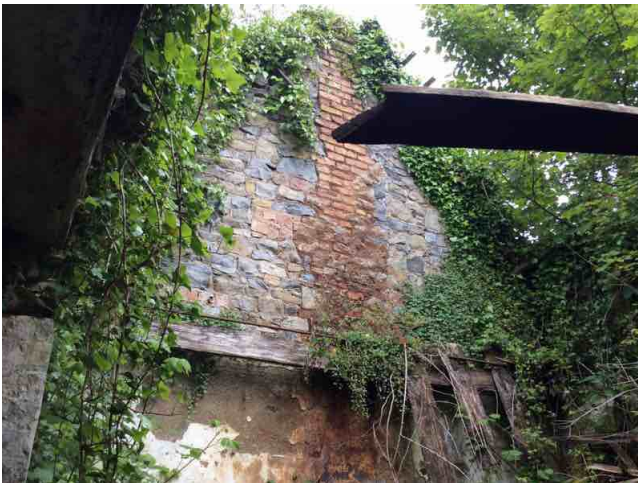
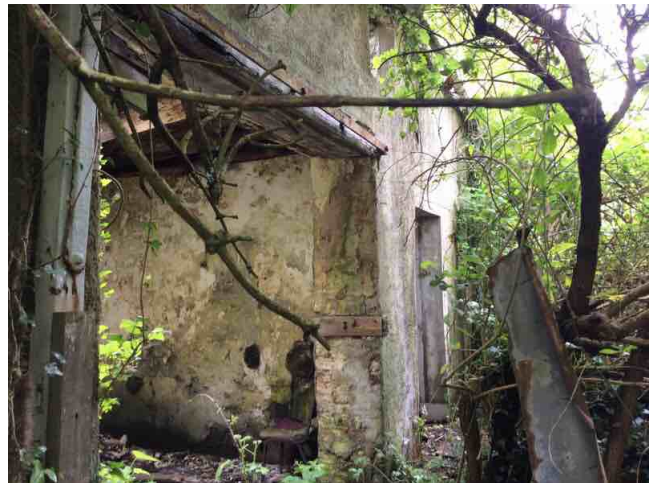
23 + 08/06/2021

The roof and upper floor in this area have collapsed onto the ground floor. No suspect asbestos containing material found.

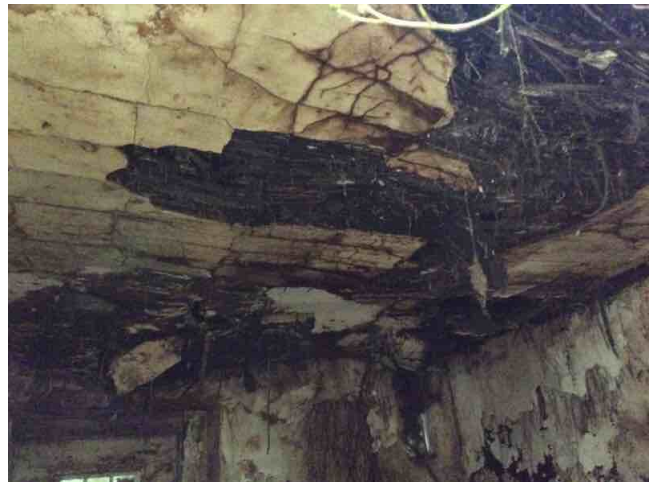
24 + 08/06/2021

The upper floor in this part of the building is in very poor condition as the roof above has collapsed onto it. No suspect asbestos containing material found.

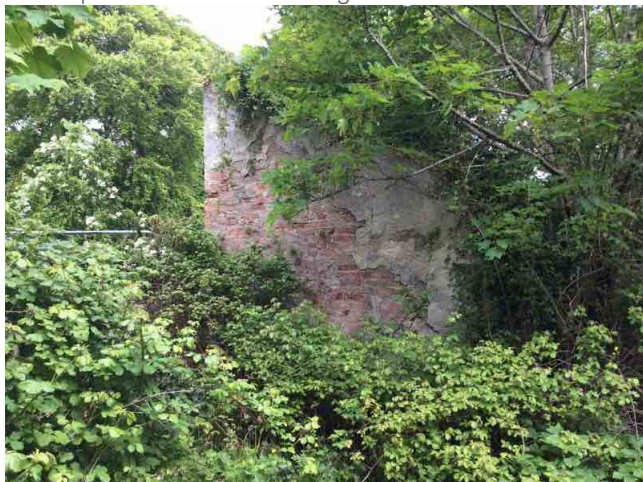
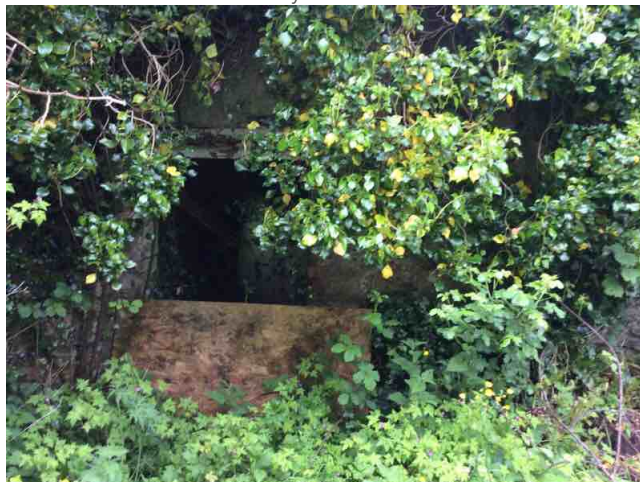
25 + 08/06/2021

The outbuildings in this area are overgrown and were inaccessible.

From what could be seen on the day, the form of construction was consistent with the other outbuildings i.e. natural stone slate on timber roof supported on stone / brick walls.

No suspect asbestos containing material was found from what could be visible on the day.

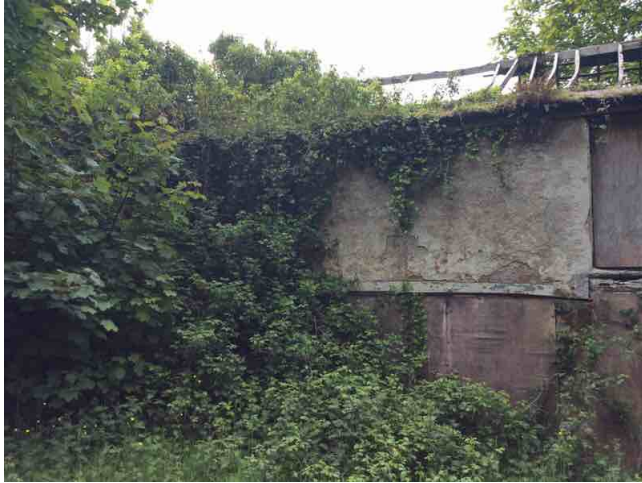
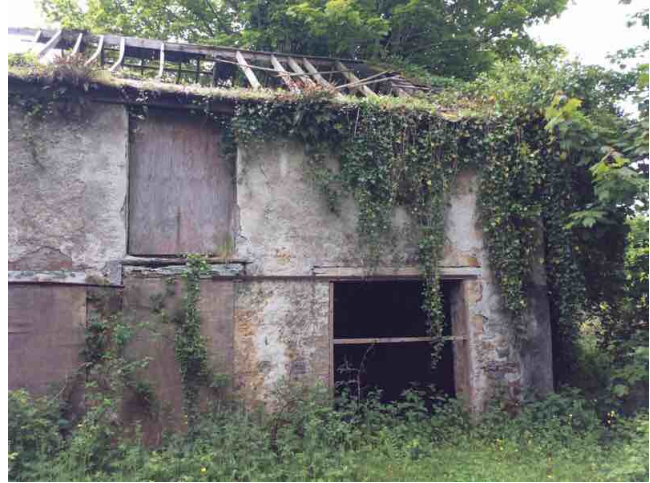
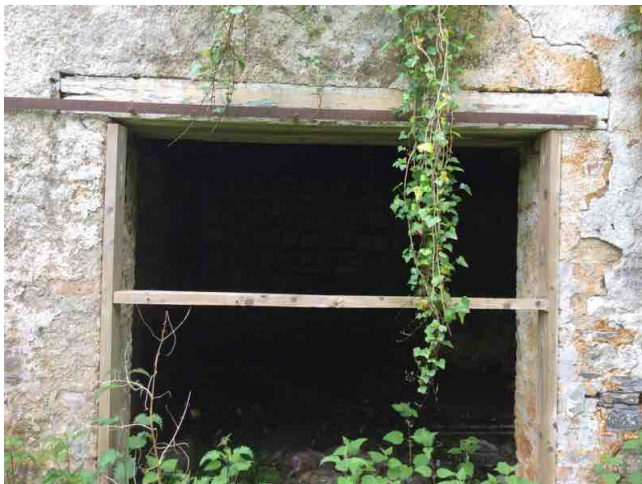
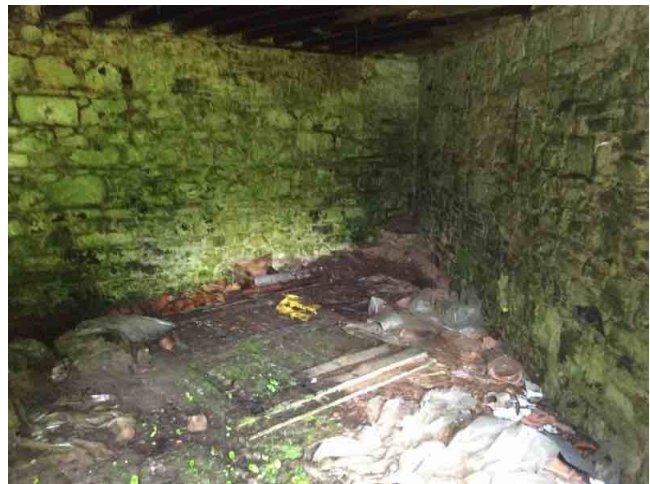
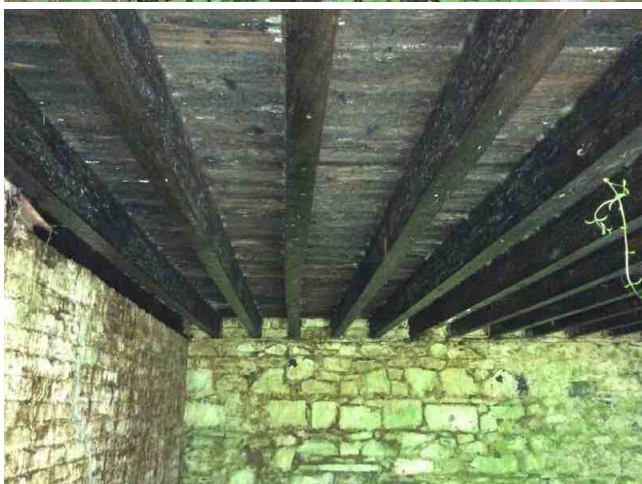
26 + 08/06/2021

This is an outbuilding with an upper floor.

The roof slates and some structural timber on the roof have collapsed but the upper floor appears to be in a moderate condition considering the are saturated.

The stone walls appear to be in a good condition throughout.

The eastern half of this building was inaccessible. No suspect asbestos containing material was found from what could be visible on the day.

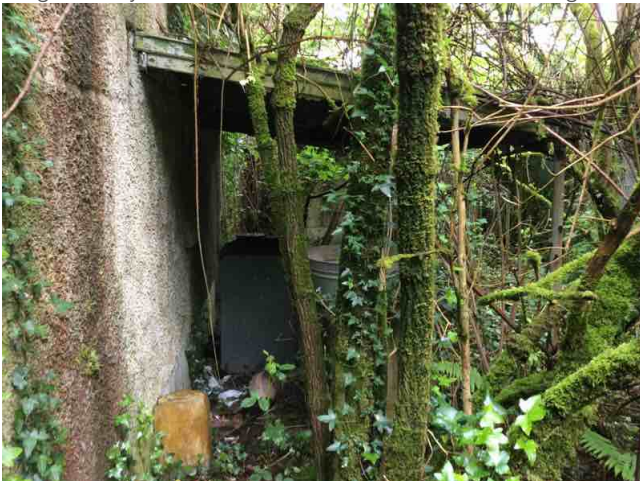
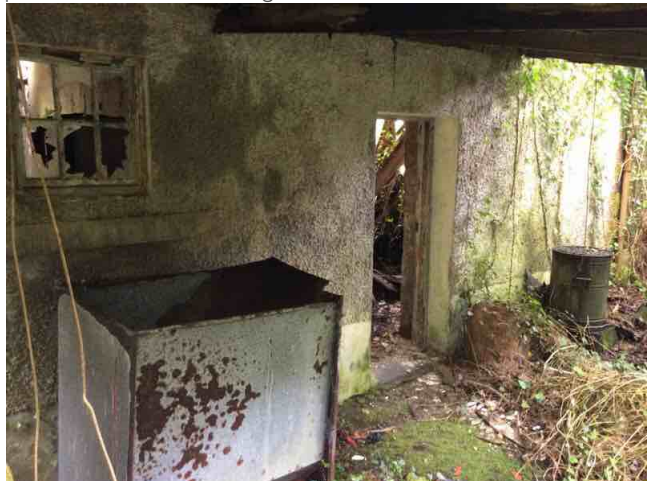
22 + 08/06/2021

Single storey lean to roof to the side of the outbuilding. No suspect asbestos containing material found.

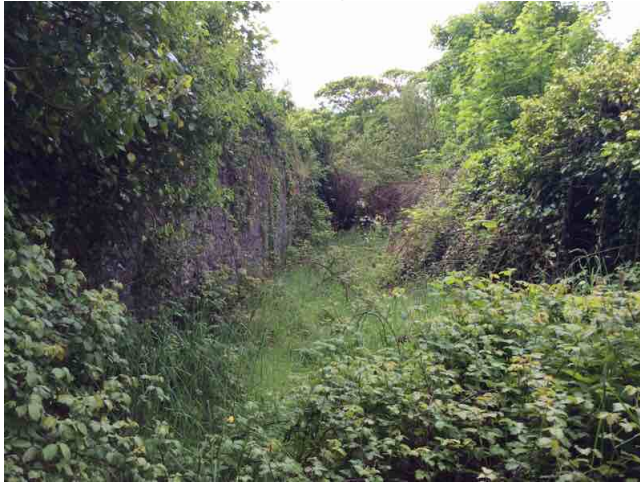
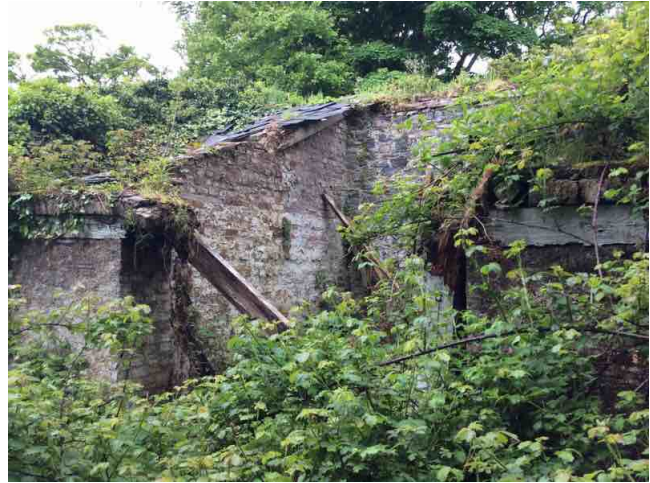
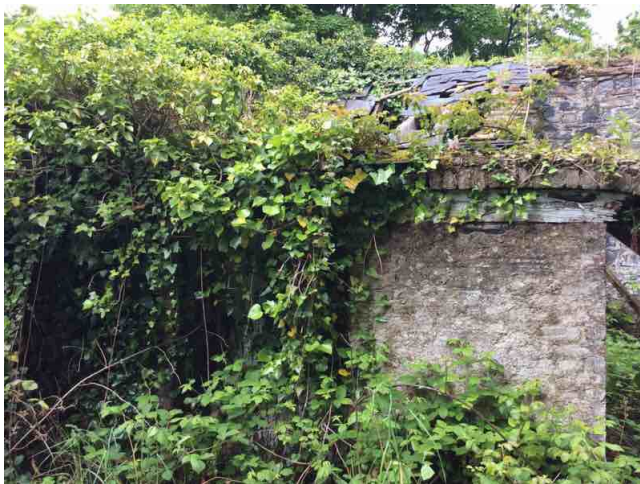
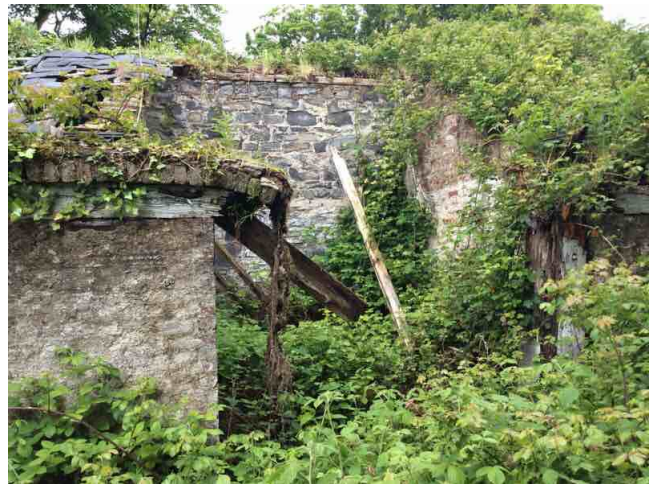
27 + 08/06/2021

The outbuildings in this area are overgrown and were inaccessible.

From what could be seen on the day, the form of construction was consistent with the other outbuildings i.e. natural stone slate on timber roof supported on stone / brick walls.

No suspect asbestos containing material was found from what could be visible on the day.

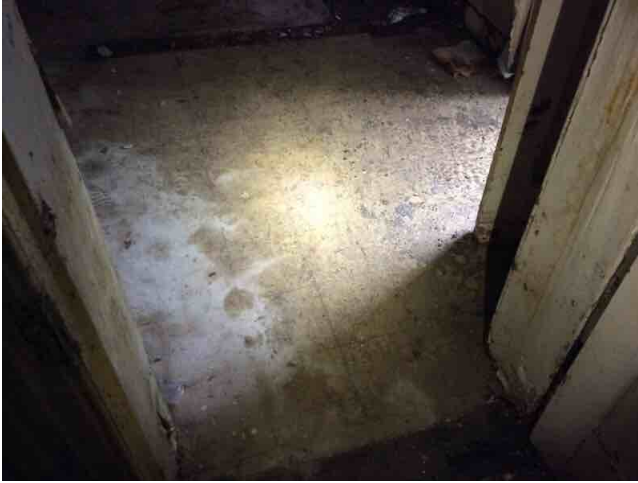
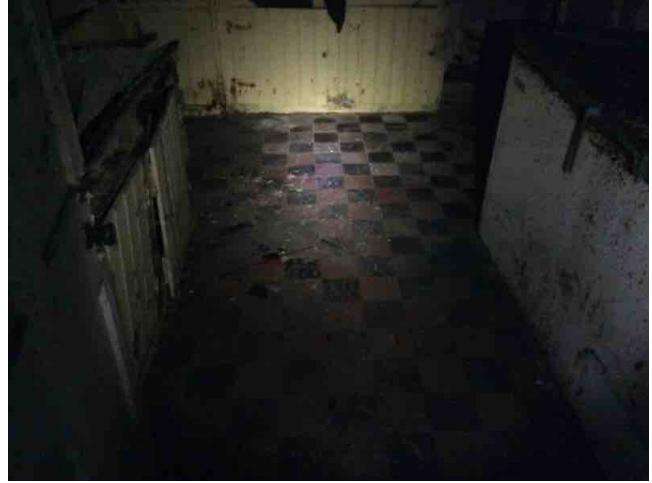
15 08/06/2021

Photographic record of floor tiles to this area at ground floor level.

Sample ref. RH02 was taken from floor tiles and adhesive and asbestos was found in the chrysotile form. All floor tiles and underlying adhesive in this area should be assumed to contain asbestos.

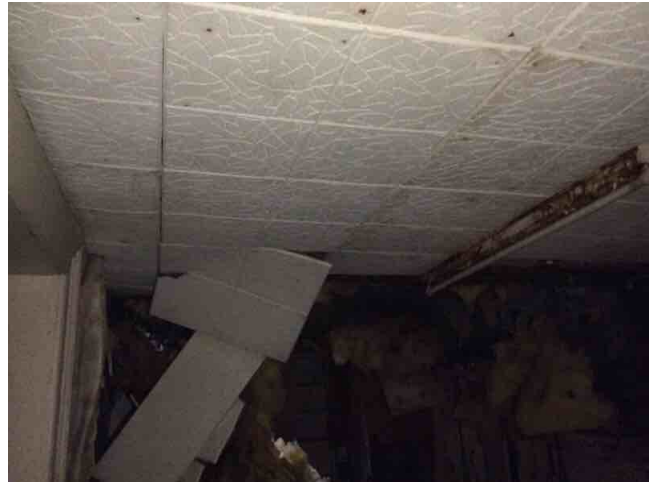
14 08/06/2021

The ceiling tiles in this room were identified as a possible asbestos containing material.

Sample ref. RH01 was taken and asbestos was not found.
