# Stage 1 Road Safety Audit

Proposed Housing Development at Robbers Lane, Maugheraboy, Sligo

On behalf of Sligo County Council

August 2021

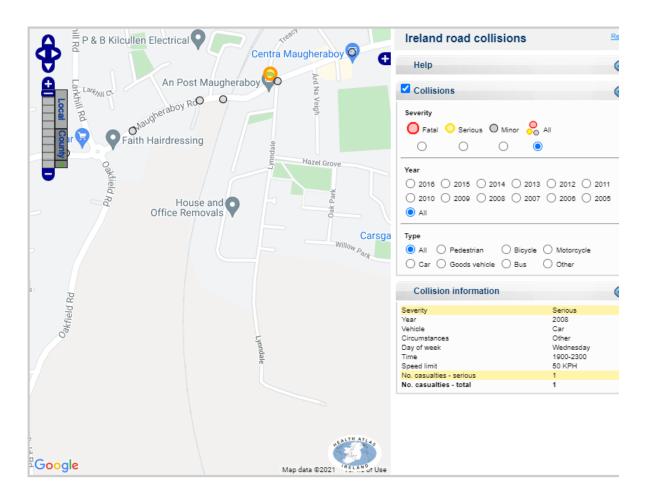
Road Collision Data available on the Road Safety Authority Database, within the period 2005 to 2016, recorded two collisions in the immediate vicinity of the proposed site. Both collisions occurred at the junction of Robbers Lane and Church Hill. One collision is listed as resulting in a serious injury.

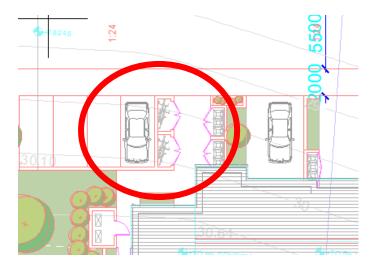
#### 3.2.2 Bin Stores

**Problem:** The bin/bicycle stores are directly adjacent to the car parking bays. This occurs in 4 locations on the south cul de sac. Drivers' visibility of approaching pedestrians on the footpath is likely to be restricted by the walls of the bin store.

Hazard: Vehicle/pedestrian impacts may result.

**Recommendation:** Ensure drivers have adequate visibility of pedestrians on the footpath.

3.2.2 Bin Stores	YES	YES Design to be adjusted at detail design and provided at Construction Stage to ensure adequate visibility as recommended		
3.2.3 Pedestrian Railing at Post Office	YES	YES: to be included in tender drgs and provided: Construction Stage

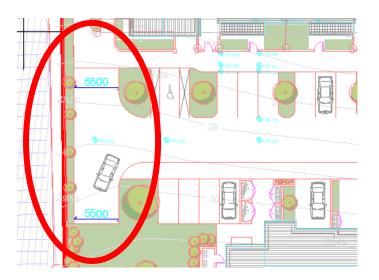
#### 3.3.1 Pedestrians Desire Lines – South Cul-de-sac

**Problem:** There is no footpath linkage for pedestrians to travel from the north to the south of the southern cul-de-sac other than the far eastern end.

**Hazard:** Pedestrians wishing to cross this road are likely to walk in between the parked vehicles and cross the road. Risk of vehicular impact results.

**Recommendation:** Provide a footpath to the perimeter of the turning head.

3.3.1 Pedestrian Desire line Southern cul de sac	YES	NO	NB A new road crossing has been included the part 8 Planning proposals	YES
3.3.2 Parallel Parking at South Eastern Corner	YES	NO	NB These spaces have been omitted from the part 8 Planning proposals	YES

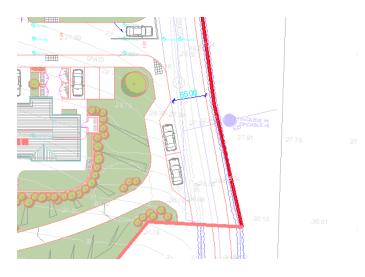
#### 3.3.2 Parallel Car Parking Spaces – South-eastern corner

**Problem:** Two parallel car parking spaces are indicated in the south-east corner of the side. It is not clear how entry/exit to these spaces is intended to be achieved as there is no space provided for the driver to turn the vehicle.

**Hazard:** There is risk that the driver will reverse up to the southern cul-de-sac in order to undertake a turn in the moth of this junction. Impact with vehicles exiting the cul-de-sac may occur.

Recommendation: Amend these spaces to be perpendicular.

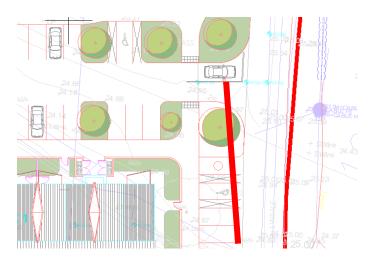
#### 3.3.3 North Cul-de-sac : Junction Visibility

**Problem:** There are a number of car parking bays to the south of the northern cul-de-sac junction. High sided vehicles parked in these bays may restrict visibility for drivers attempting to exit the cul-de-sac.

Hazard: Drivers may errantly exit the cul-de-sac into the path of oncoming vehicles.

Recommendation: Ensure adequate junction visibility is provided.

3.3.3. Junction Visibility Northern Cul-De-Sac	YES	YES Parking layout has been adjusted to allow sight lines		
3.3.4 Connection existing estate road	YES	YES Footpath to be amended recommended

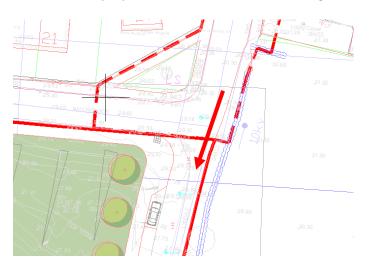
#### 3.3.4 Connection with Existing Estate Road – Entering Traffic

**Problem:** The proposed kerb line deviates to the right on entering the development.

**Hazard:** Users entering the development may cross into the opposing traffic lane and impact with exiting vehicles.

**Recommendation:** Amend the road layout to ensure a smooth driving line without any sharp changes in alignment.

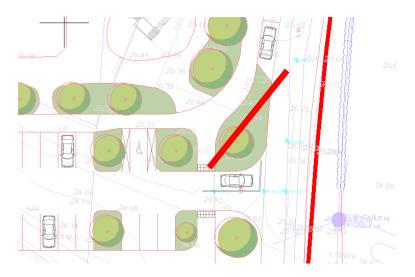
#### 3.3.6 North cul-de-sac - Pedestrian Visibility

**Problem:** There is proposed tree planting in the area of the informal pedestrian crossing at the junction of the northern cul-de-sac. The tree may restrict visibility between the car driver and pedestrian.

Hazard: The pedestrian may commence crossing the road and be struck by a right turning vehicle.

Recommendation: Omit all tall planting in the visibility zone.

3.3.5 Connection existing estate road	YES	YES Footpath to be amended recommended		
3.3.6 North Cul de sac Pedestrian Visibility	YES	YES Planting has been omitted as recommended

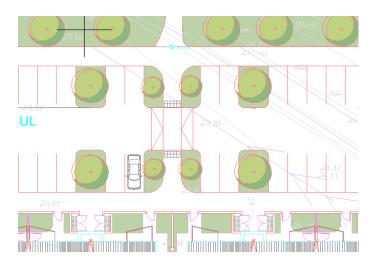
#### 3.3.7 Northern cul-de-sac - Road Hump

**Problem:** There is a ramp/ road hump located on the northern cul-de-sac. The length of the flat element of the hump appears to be circa 2m. There is risk that low vehicles may ground on the ramp.

**Hazard:** Mechanical damage sustained here may result in mechanical failure / loss of vehicle control elsewhere on the high-speed network.

Recommendation: Widen the ramp to ensure the ramp does not result in vehicle grounding.

Audit Stage:Stage 1		ment of 62 no. reside oute No: N/A		Audit: August 21	
num stugenstuge 1		ate no. npr	Dute of	Addit: Adjust 21	
3.3.7 Northern Cul De Sac Road Hump	YES	NO		The maximum height of the ramp will be 100mm with sufficient gradients on the approaches to prevent grounding.	YES
To be Completed b	y Designe				To be Completed by Audit Team Leader
Paragraph No. in Safety Audit Report	Problem accepted (yes/no)	Recommended meas (yes/no)	ure accepted	Describe alternative measure(s). Give reasons for not accepting recommended measure. Only complete if recommended measure is not accepted.	Alternative measures or reasons accepted by auditors (yes/no)

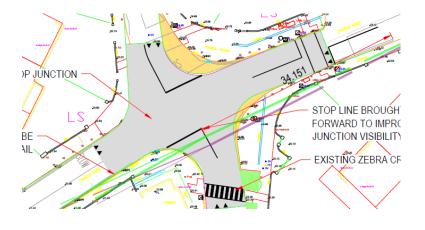
#### 3.3.10 Church Hill Road Centreline

Problem: The proposals include for removal of the Church Hill centreline.

**Hazard:** Drivers intending to turn right into Robbers Lane may position their vehicle too far to the right for opposing traffic to pass. The opposing user may suddenly slow/stop and be subject to rear end shunts.

**Recommendation:** Provide a road centreline.

3.3.10 Maugherboy Rd Centreline	YES	YES Road Centre line ha included as recomr			
3.3.11 Robbers Lane Parking bay	YES	YES Parking bays have I as recommended	been omitted

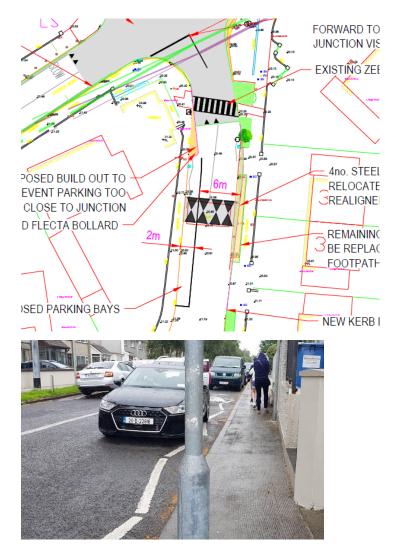
#### 3.3.11 Robber's Lane Car Parking Bay

**Problem:** The proposals introduce a formal car parking bay to the western side of Robbers Lane. This bay is in close proximity to the zebra crossing.

**Hazard:** High sided vehicles parked in this bay are likely to restrict visibility to/from pedestrians on the western side of the zebra crossing. Additionally, the car parking bays overlap with the zone for zig-zag road markings.

**Recommendation:** Omit car parking that may interfere with intervisibility to/from pedestrians. This can be assumed to be the zone of zig-zag markings.

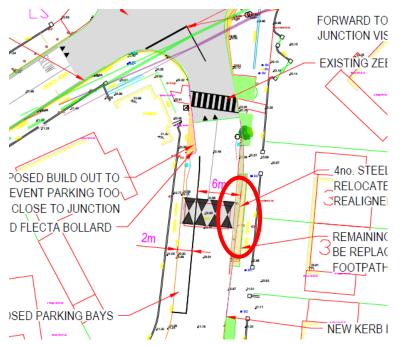
#### 3.3.12 Robbers Lane Road Hump

**Problem:** The road in the area of the existing road hump is proposed to be widened. There are no proposals to extend the road hump to abut the revised kerb.

**Hazard:** Two-wheeled vehicles may attempt to avoid the road hump by travelling in the area of widened road. These users may errantly strike either the edge of the road hump or the kerb and lose vehicle control.

**Recommendation:** Extend the road hump to meet with the revised kerb.

3.3.12 Robbers lane Hump	YES	YES Road hump has bee and table top exter			
3.3.13 Robbers Lane: Footpath build out taper	YES	YES Footpath build out been included as re

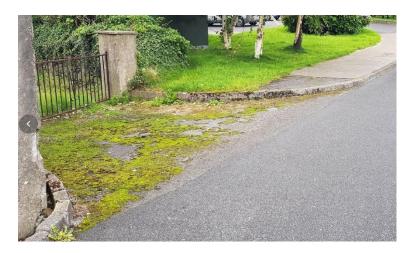
#### 3.3.14 Robbers Lane – Footpath Build Out – Driveway Crossing

**Problem:** The provision of a footpath at this location is likely to encourage greater use of the footpath on this side of the road. The existing footpath is terminated for the cottage driveway. No dropped kerb is provided on the footpath to assist mobility impaired users to cross this driveway.

Hazard: Pedestrians may trip/stumble due to the high kerb.

**Recommendation:** Continue the new footpath across the unused driveway complete with dropped kerbs to allow access to unoccupied dwelling.

3.3.14 Footpath Buildout Driveway Crossing	YES	YES Footpath build out included as recomr
