TCE Compliance Report 11258 - Tubbercurry Public Realm Realm 11258

SITE INSPECTION REPORT

11258 - Tubbercurry Public Realm

DRAFT - Visual Structural Inspection of St Bridget's Hall and "Mary Jacks" Building

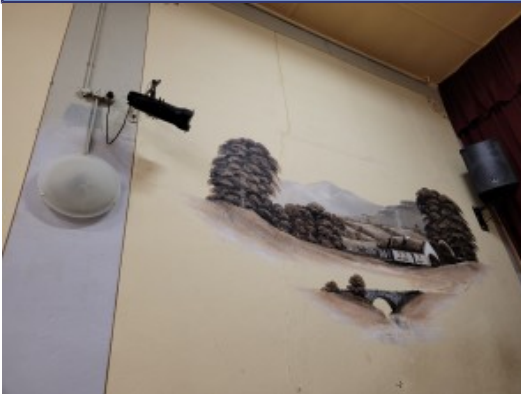
001 / 001

St. Bridget's Hall
A long vertical crack was observed in the auditorium adjacent to the stage.

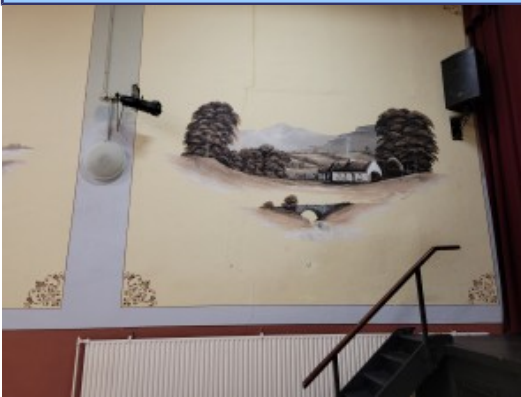
001 / 002

St. Bridget's Hall
A long vertical crack was observed in the auditorium adjacent to the stage.

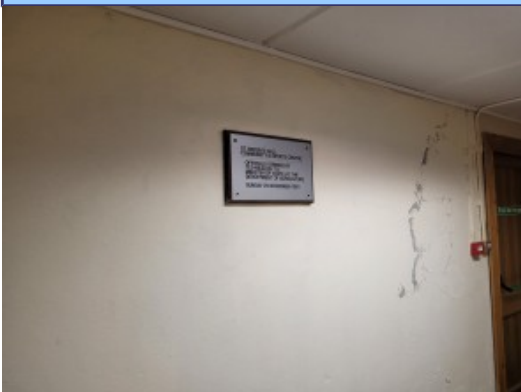
001 / 003

St. Bridget's Hall - 1980s Extension
Indication of dampness/water ingress in the corridor of the 1980s extension, plaster damaged.

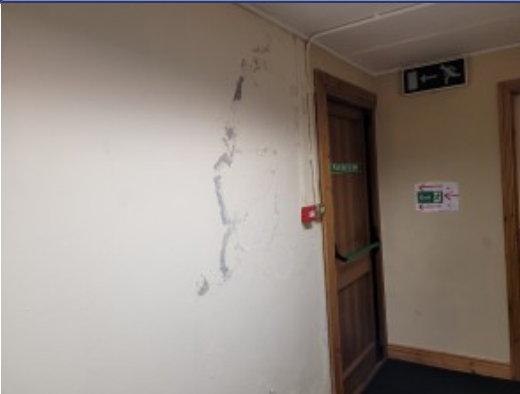
001 / 004

St. Bridget's Hall - 1980s Extension
Indication of dampness/water ingress in the corridor of the 1980s extension, plaster damaged.

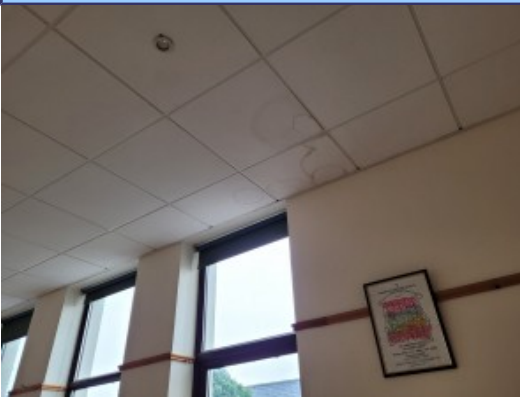
001 / 005

St. Bridget's Hall - 1980s Extension
Indication of dampness/water ingress on the ceiling in the 'snooker room' on the ground floor of the 1980s extension.

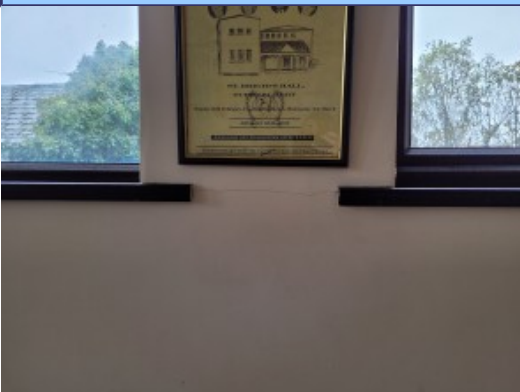
001 / 006

St. Bridget's Hall - 1980s Extension
Horizontal cracking visible in between the windows in the 'snooker room' on the ground floor of the 1980s extension.

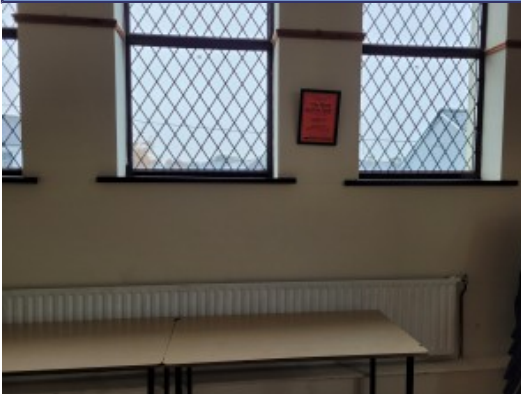
001 / 007

St. Bridget's Hall - 1980s Extension
Horizontal cracking visible in between the windows in the 'snooker room' on the ground floor of the 1980s extension.

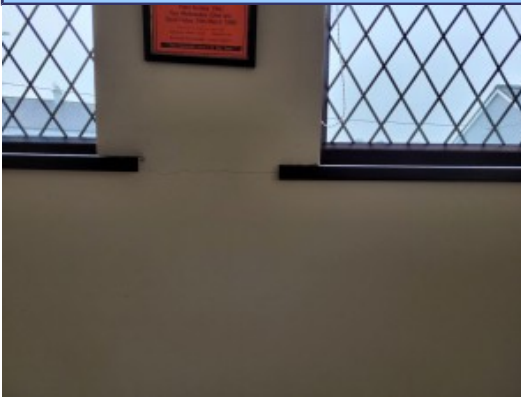
001 / 008

St. Bridget's Hall - 1980s Extension
Horizontal cracking visible in between the windows in the 'snooker room' on the ground floor of the 1980s extension.

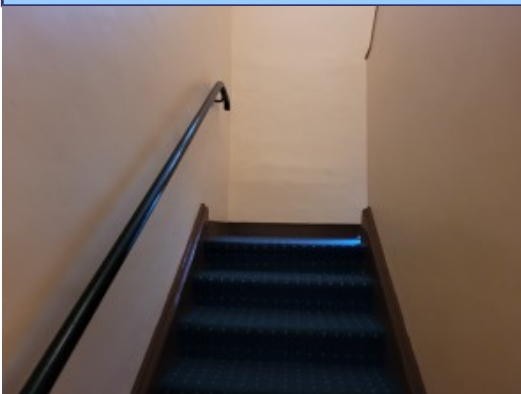
001 / 009

St. Bridget's Hall
Excessive deflection and creaking felt underfoot on the stairs adjacent to the dressing rooms at the back of the building.

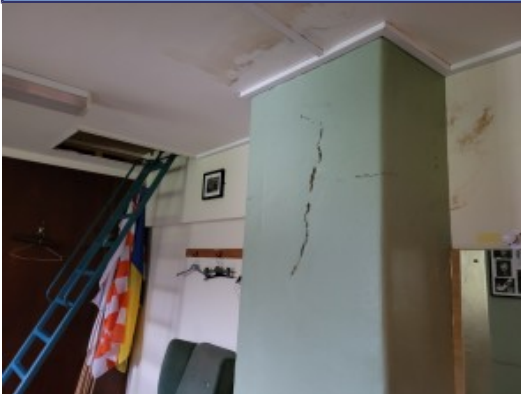
001 / 010

St. Bridget's Hall
Indication of of dampness/water ingress on the ceiling and chimney in the first floor dressing room, plaster damaged.

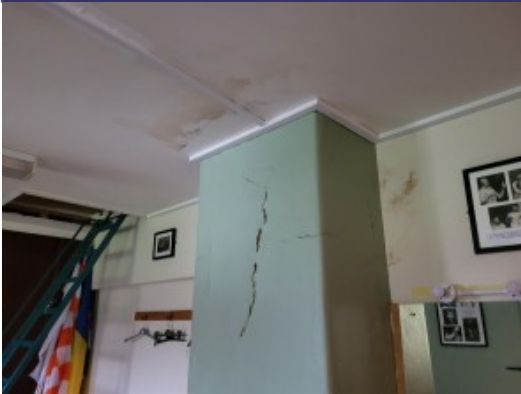
001 / 011

St. Bridget's Hall
Indication of of dampness/water ingress on the ceiling and chimney in the first floor dressing room, plaster damaged.

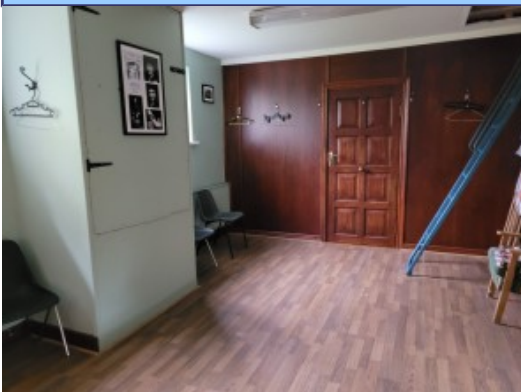
001 / 012

St. Bridget's Hall
Excessive deflection and creaking felt underfoot in the first floor dressing rooms at the back of the building.

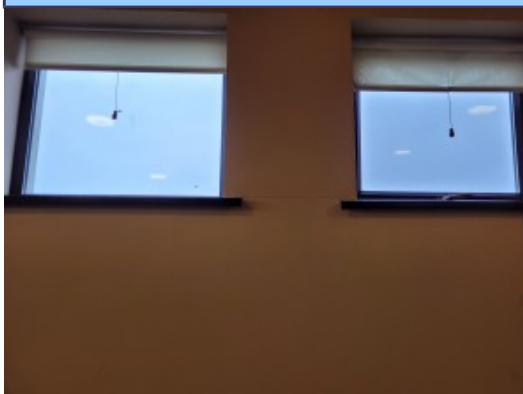
001 / 013

St. Bridget's Hall - 1980s Extension
Horizontal cracking visible in between the windows in the 'supper room' on the first floor of the 1980s extension.

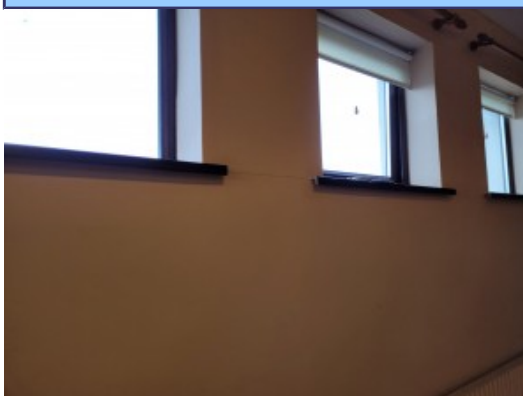
001 / 014

St. Bridget's Hall - 1980s Extension
Horizontal cracking visible in between the windows in the 'supper room' on the first floor of the 1980s extension.

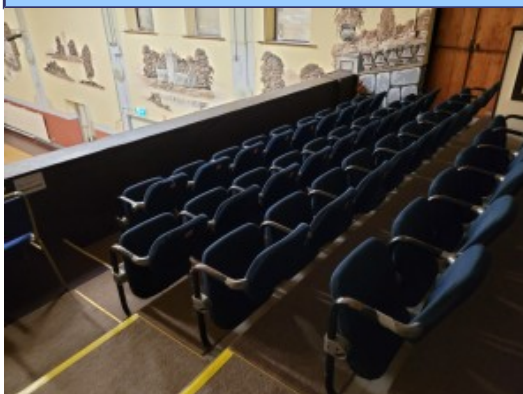
001 / 015

St. Bridget's Hall
Deflection and creaking of timber floor felt underfoot on the balcony over the Auditorium. This is on the timber build up for the tiered seating in this area, examination of the floor structure below was not possible as the floor was not exposed.

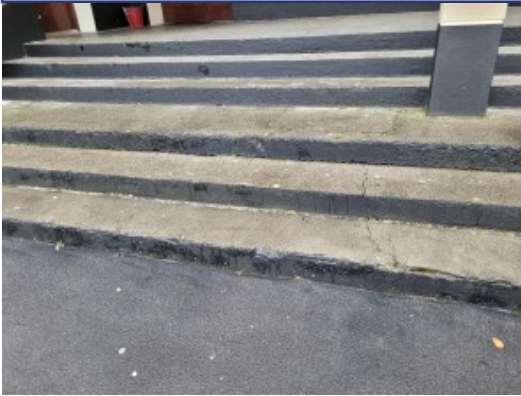
001 / 016

St Bridget's Hall - External
Some cracking apparent on front external steps.

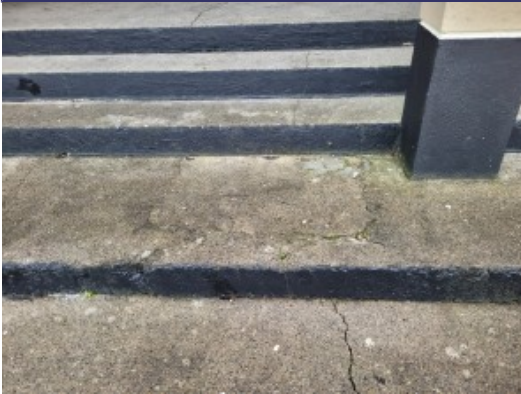
001 / 017

St Bridget's Hall - External
Some cracking apparent on front external steps.

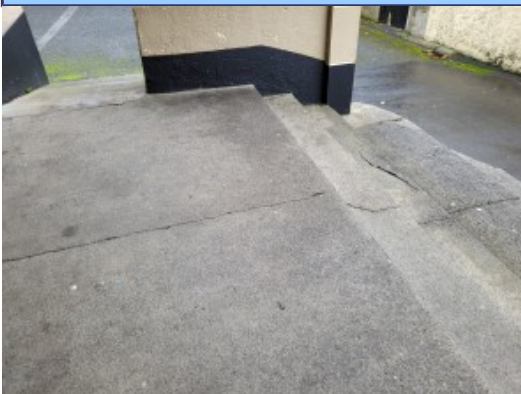
001 / 018

St Bridget's Hall - External
Some cracking apparent on front external steps.

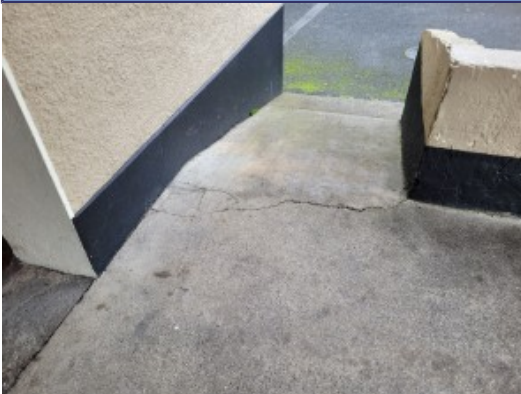
001 / 019

St Bridget's Hall - External
Some cracking apparent on front external steps.

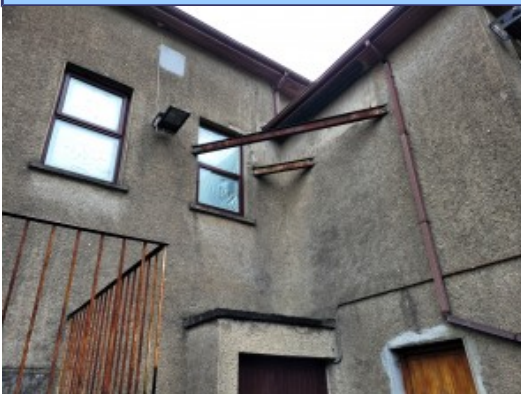
001 / 021

St Bridget's Hall - External
Two steel beams spanning from the kitchen area to the main auditorium area are very rusted and damaged. Further investigation will be required to establish their purpose and if they are to be repaired or removed.

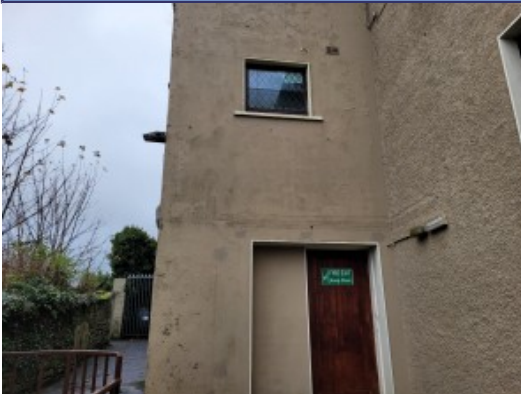
001 / 022

St. Bridget's Hall - External
Indication of dampness/water ingress on the external walls of
the 1980s extension, plaster damaged.

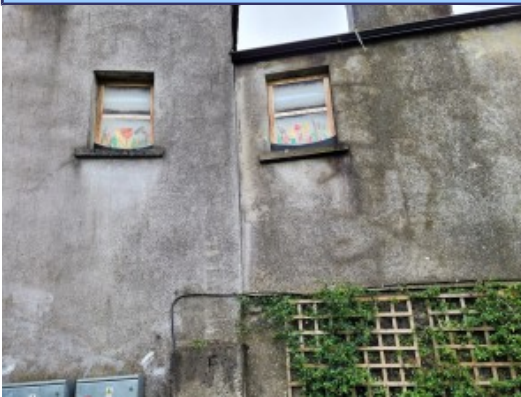
001 / 023

Mary Jacks - External
Dampness/water ingress apparent on the wall under the
chimney at the rear.

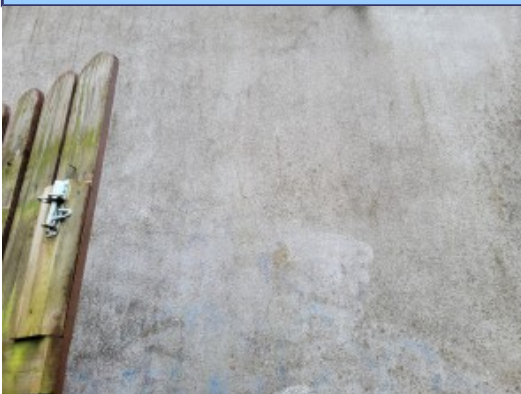
001 / 024

Mary Jacks - External
Vertical crack on side wall.

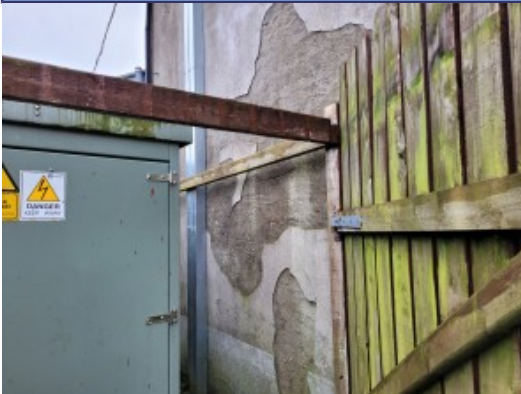
001 / 025

Mary Jacks - External
Dampness/water ingress apparent on side wall, plaster damaged
and fallen off in this area.

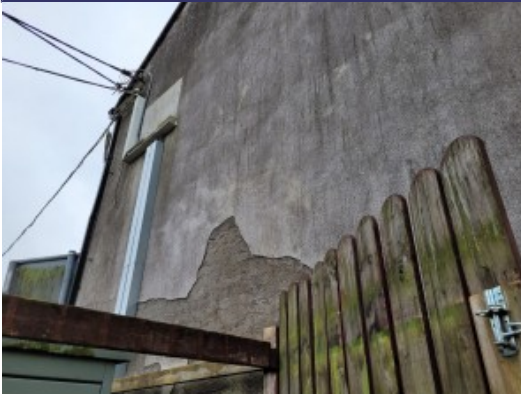
001 / 026

Mary Jacks - External
Dampness/water ingress apparent on side wall, plaster damaged
and fallen off in this area.

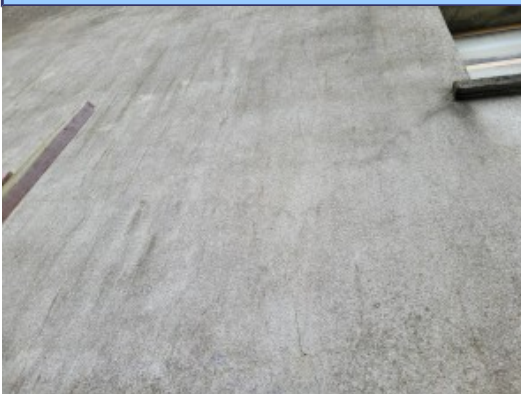
001 / 027

Mary Jacks - External
Settlement cracking on side wall.

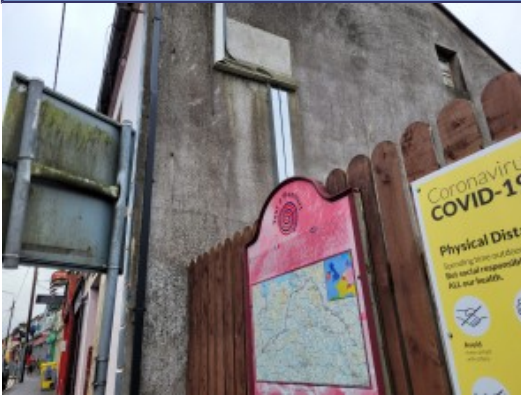
001 / 028

Mary Jacks - External
Horizontal crack on side wall.
