Title:
Rathellen House and Outbuilding
Existing, Demolitions and Consolidation
of Building Fabric - Ground Floor Plan

COADY
ARCHITECTS

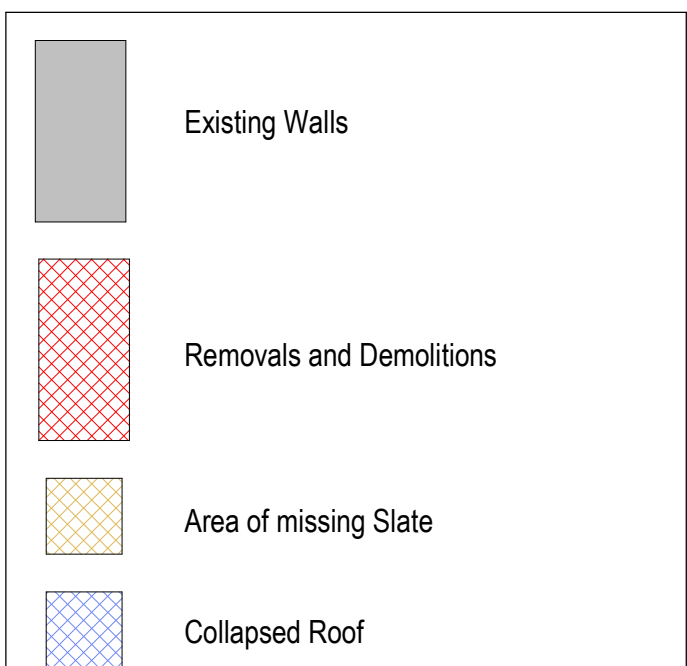
1. Roof: Existing natural slate roof, partially collapsed, in a poor saturated condition due to water ingression, on cut timber roof trusses
2. Walls: Existing walls are of stone rubble and brick single leaf traditional construction lime harling and some local areas of later cement render on the external facades
3. Windows: Sash Timber windows; Surviving windows to be restored and replaced in existing ope
4. Rainwater Goods: Surviving cast iron rainwater goods to be salvaged and reused, where intact.
5. Chimney: Decorative nineteenth century chimneys, which give a vertical emphasis to the roof, are to be consolidated and repaired. Remnants of existing chimney which have fallen, to be retained and rebuilt
6. Cills: Stone window sills to existing ope's to be retained and repaired
