PPP Social Housing Bundle 3:  
Development at Finisklin, Co. Sligo  
Stage 1&2 Road Safety Audit

# PPP Social Housing Bundle 3: Development at Finisklin, Co. Sligo

## Stage 1&2 Road Safety Audit

This report describes the findings of a Stage 1&2 Road Safety Audit associated with the proposed Social Housing Development at Finisklin, Co. Sligo.

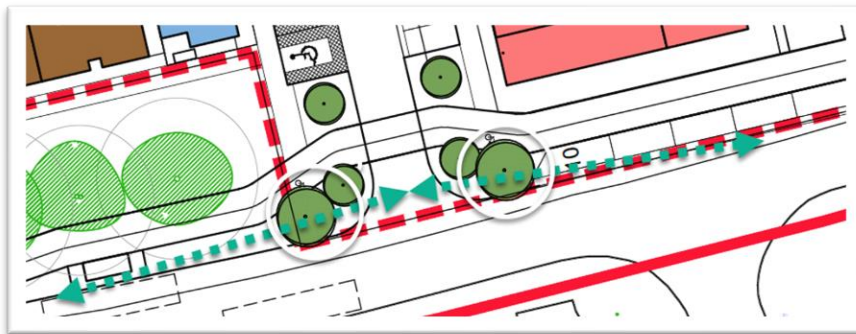
**Figure 2.1 – Planting Obstructing Visibility**

**Location:** Main Access Junction Connecting to Sea Road

Landscaping and tree planting appears to impede the envelope of visibility at the access junction; it could also obscure the presence of a pedestrian waiting to cross the access road. This could lead to collisions between development traffic and mainline traffic streams.

The landscaping and tree planting should be relocated to mitigate the risks described.

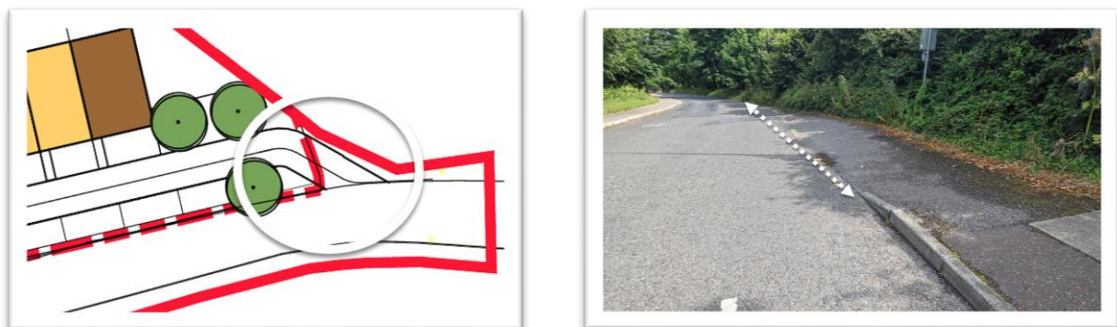
**Figure 2.2 – Southern Termination of Footpath & Cycle Path**

**Location:** Southern Boundary of Site on Sea Road

The proposed footpath and cycle path terminate abruptly, prior to connection with existing facilities to the south of the development. This could result in pedestrians & cyclists emerging into the road carriageway without warning, placing them in direct conflict with vehicles.

The footpath and cycle path should be extended to meet the existing facilities.

Problem Reference (Section 2)	Designer Response Section			Audit Team Response Section
	Problem Accepted ( yes / no )	Recommended Measure Accepted ( yes / no )	Alternative Measures or Comments	Alternative Measures Accepted ( yes / no )
2.1	Yes	Yes		
2.2	Yes	Yes	Sligo County Council have noted this also and will liaise with An Post who own the strip of land between our site and the existing footpath. We will extend the footpath to the boundary of SCC owned land and the remaining section will have to be coordinated by SCC.	Noted with thanks.
2.3	Yes	Yes

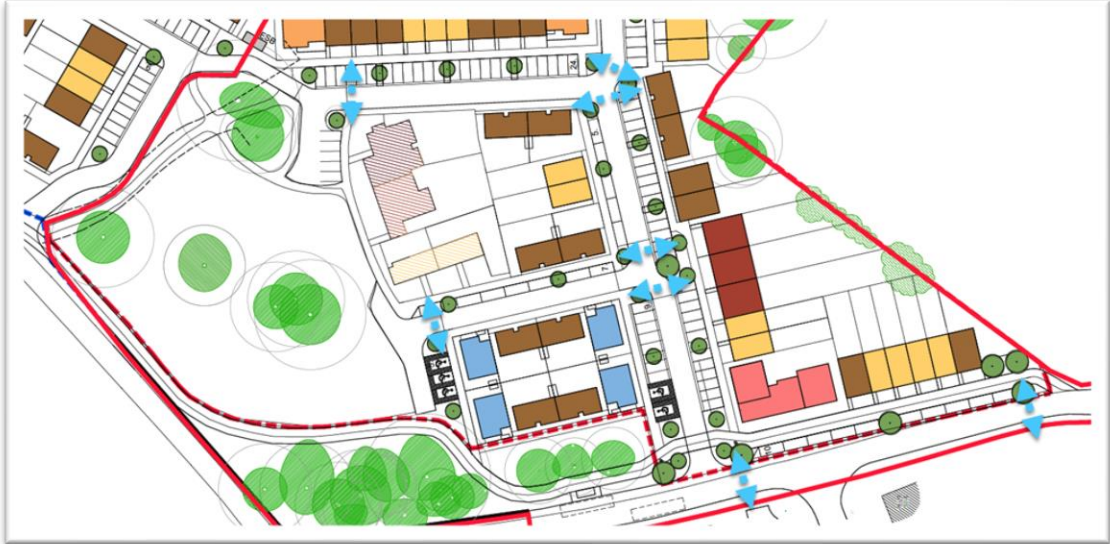
**Figure 2.3 – Some Examples of Where Crossing Points Have Been Obstructed**

**Location:** Internal & External Streets

Direct crossing points on many of the key pedestrian desire lines have been obstructed by parking or planting. This could result in conflicts between pedestrians and general traffic.

Formal and direct courtesy crossings should be aligned with pedestrian desire lines where they are likely to occur on the internal and external road network.
