PROVISION OF HOUSING DEVELOPMENTS AT GELDOLF DRIVE AND BENSON COURT CRANMORE CO. SLIGO

SCREENING FOR APPROPRIATE ASSESSMENT

SEPTEMBER 2023

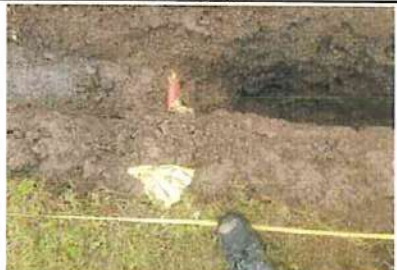
| 0 | 0.3 | TOPSOIL | | | | |
| 0.3 | 0.8 | MADE GROUND comprising firm dark grey brown slightly sandy gravelly clayey SILT with a medium cobble and boulder content, occasional concrete, plastic and metal fragments. | | | | |
| 0.8 | 1.5 | Firm to soft light brown grey slightly sandy gravelly CLAY with a medium cobble content and boulder content (up to 400mm). Sand is medium. | | | | |

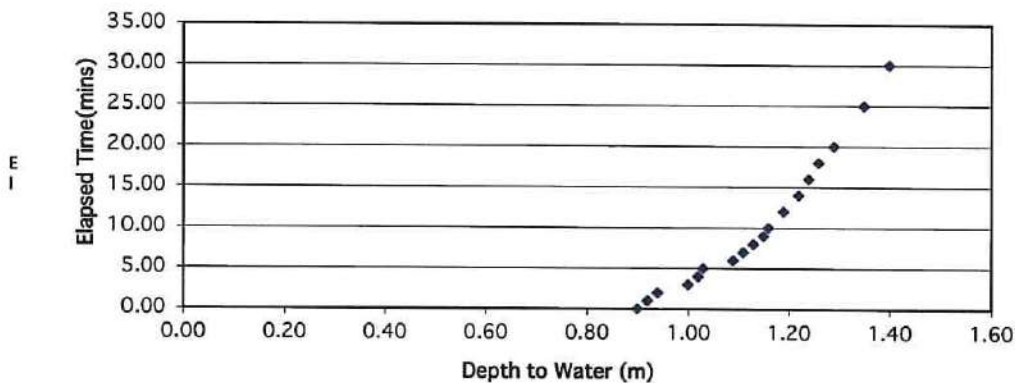
$f = 0.003589744 \text{ m/min}$ or $5.983E-05 \text{ m/sec}$

Depth of water vs Elapsed Time (mins)

To obtain a measure of the infiltration rate of the sub-soils, water was poured into the test pit, and records taken of the fall in water level against time. The tests are usually carried over two cycles following initial soakage. Designs are based on the slowest infiltration rate, which is calculated from the final cycle.

The infiltration rate is the volume of water dispersed per unit exposed area per unit of time, and is generally expressed as metres/minute or metres/second. In these calculations the exposed area is the sum of the base area and the average internal area of the pit sides over the test duration. The results for the final test cycle are as follows

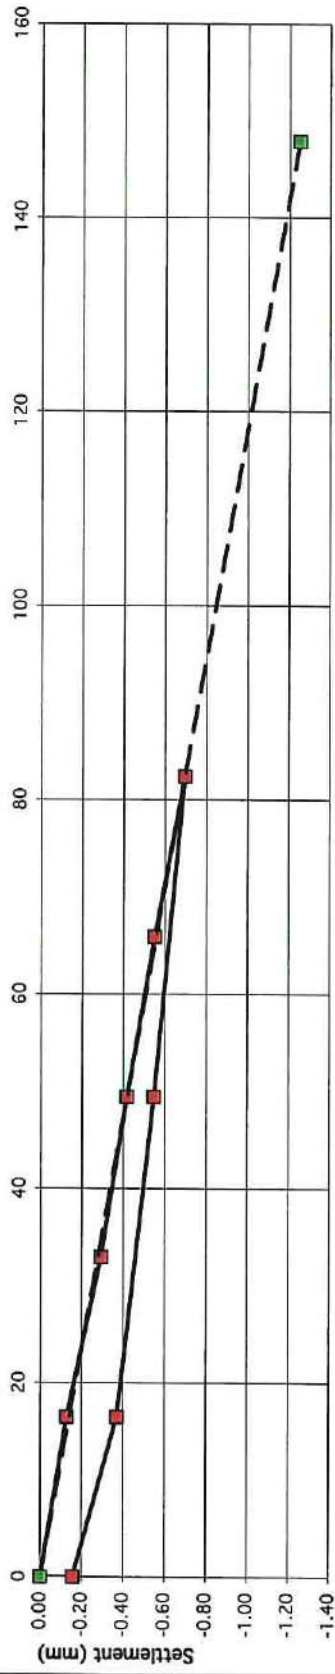
Pressure / Settlement

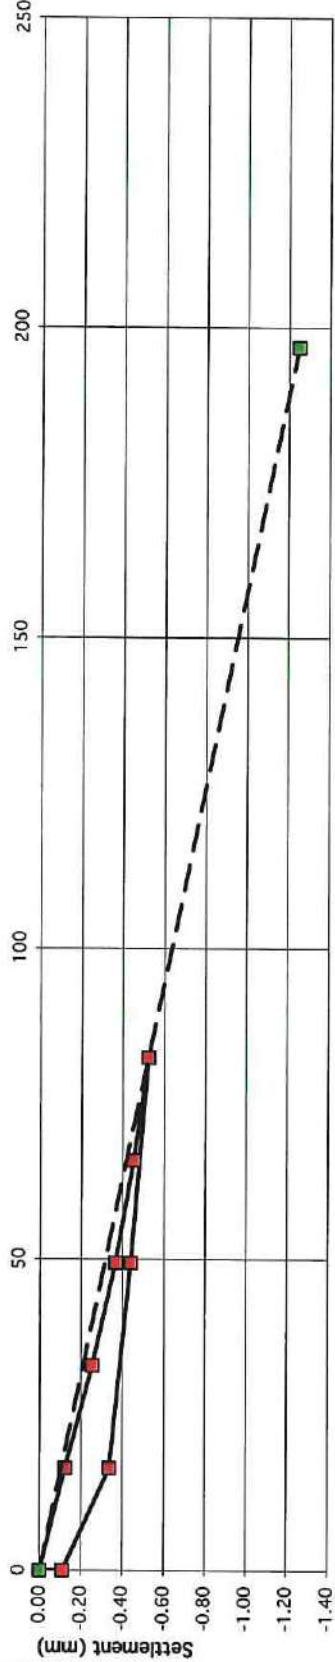
Pressure / Settlement

| Gradient at 1.25 mm settlement intersection = 157 | 28.8 % |

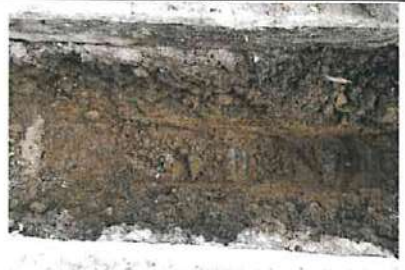
| 0 | | 0.5 | | MADE GROUND comprising Hardcore FILL | | | | |
| 0.5 | | 1.5 | | MADE GROUND comprising of dark grey brown sandy silty/clayey GRAVEL with a high cobble and boulder content and rare fragments of plastic, metal and building rubble. | | | | |
