## SOCIAL HOUSING DEVELOPMENT

### RATHELLEN HOUSE, FINISKLIN, SLIGO

#### Refurbishment Asbestos Survey Report

SHB3-FIN-CS-RPS-RP-RP010

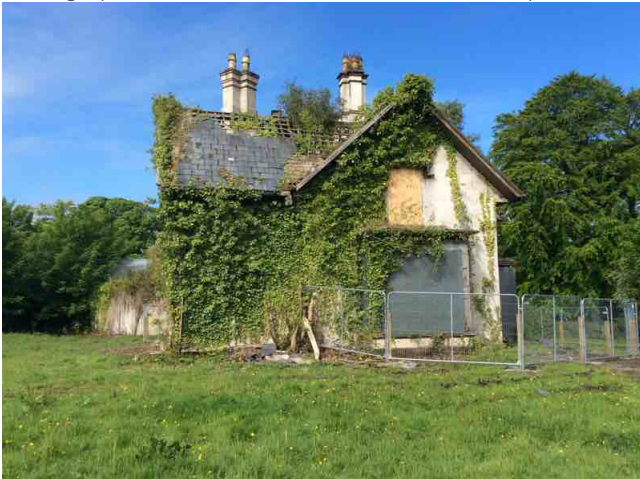
19 08/06/2021

Photographic record of northern elevation. No suspect asbestos containing material found.

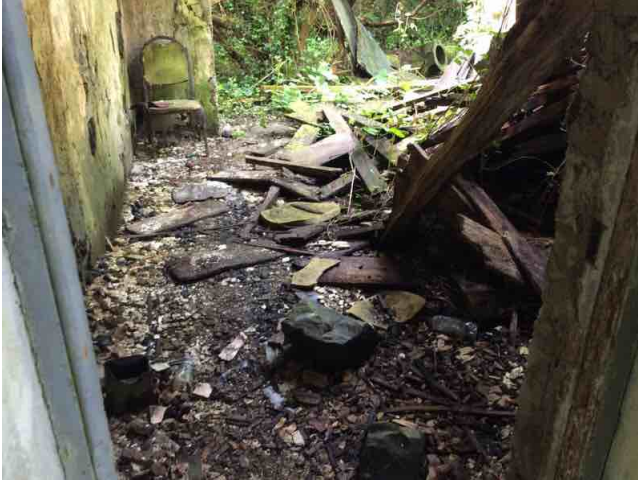
23 + 08/06/2021

The roof and upper floor in this area have collapsed onto the ground floor. No suspect asbestos containing material found.

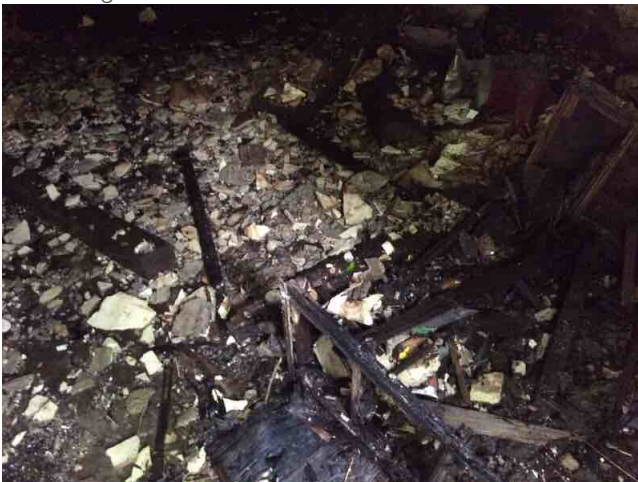
24 + 08/06/2021

The upper floor in this part of the building is in very poor condition as the roof above has collapsed onto it. No suspect asbestos containing material found.

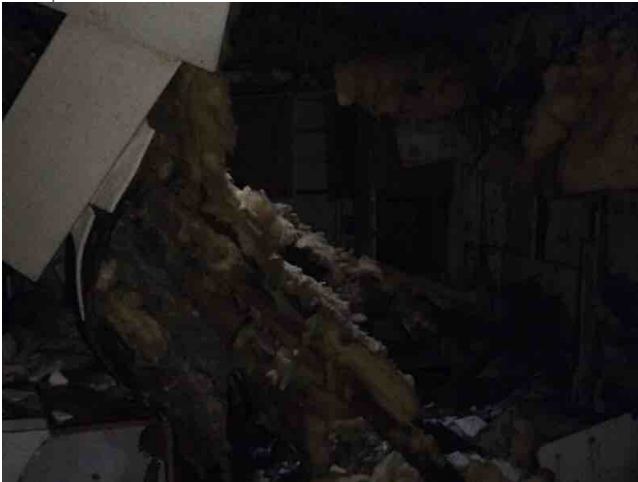
The ceiling tiles in this room were identified as a possible asbestos containing material.

Sample ref. RH01 was taken and asbestos was not found.

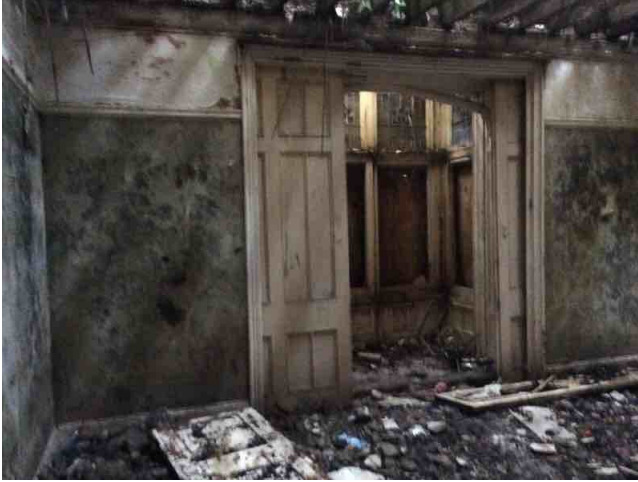
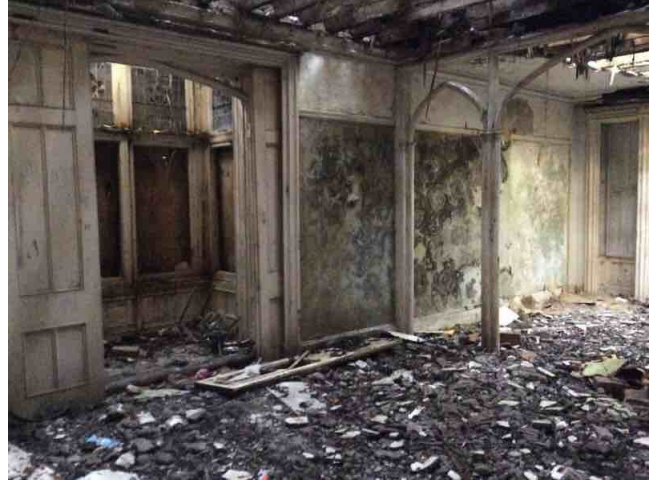
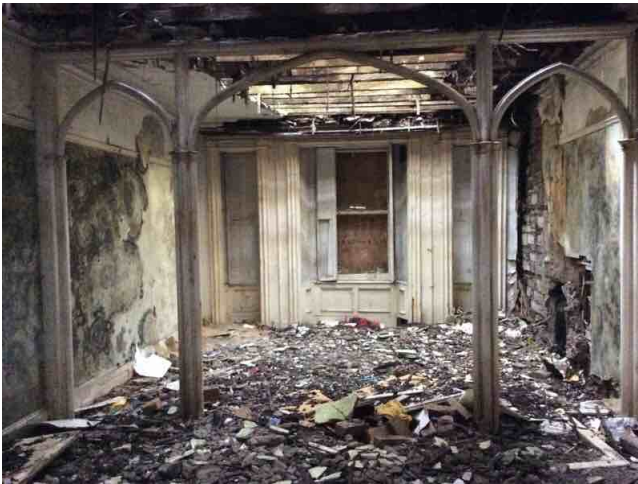
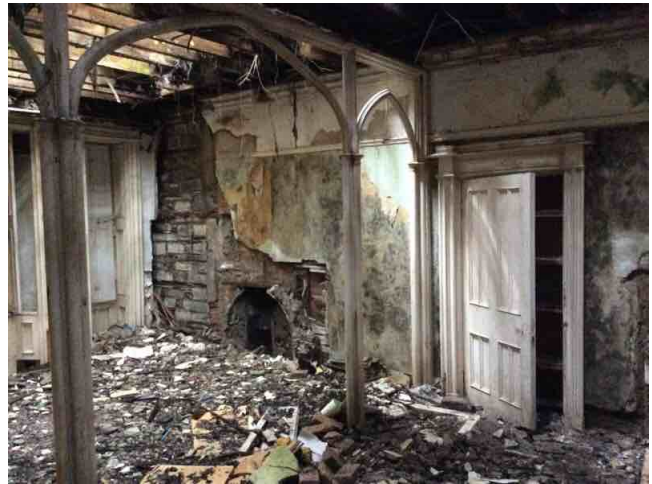
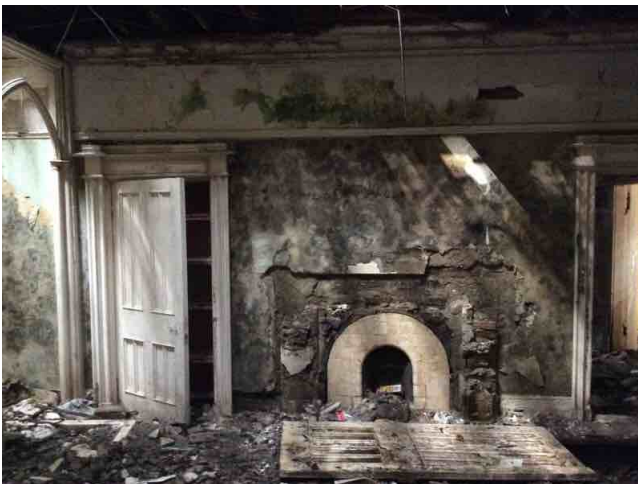
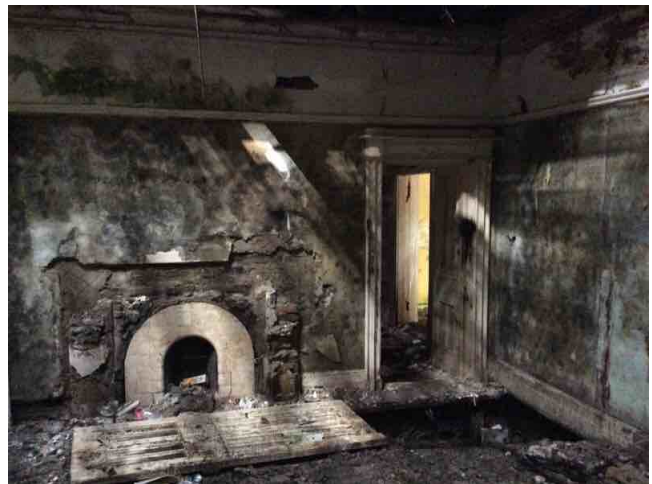
1 08/06/2021

Photographic record of internal ground floor area. No suspect asbestos containing materials found.

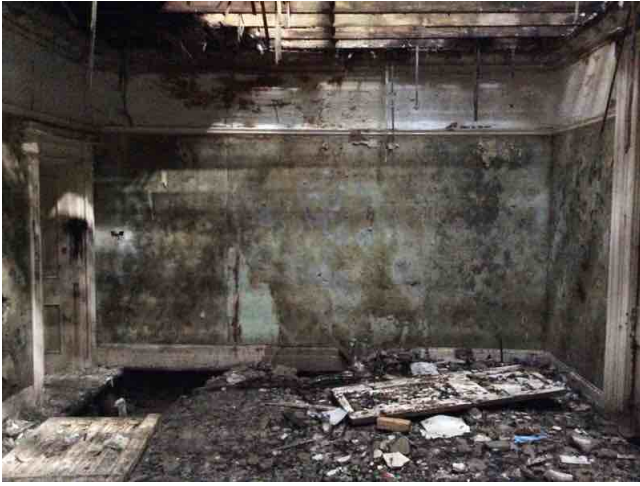
2 08/06/2021

Photographic records taken from ground floor of features on the first floor. For safety reasons, access to the first floor was not possible.

As the materials of construction appear to be consistent throughout the house, the presence of asbestos containing materials is very unlikely.

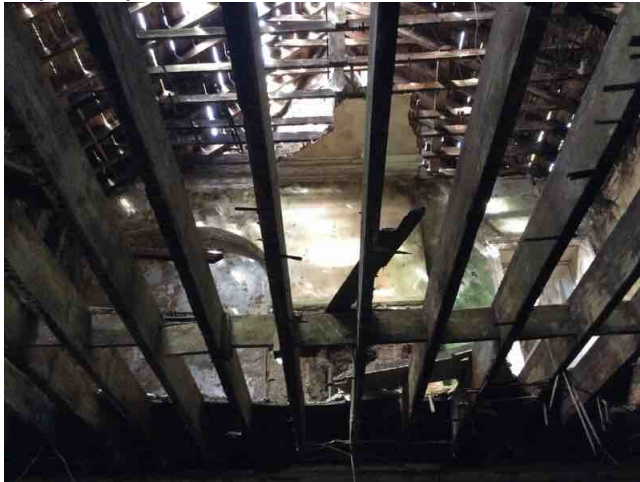
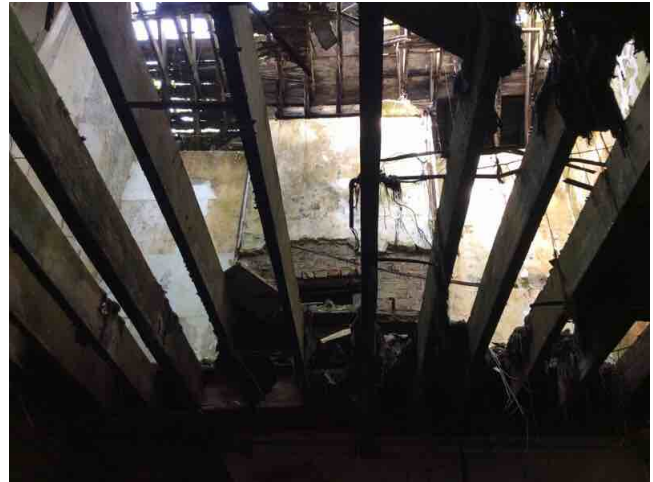
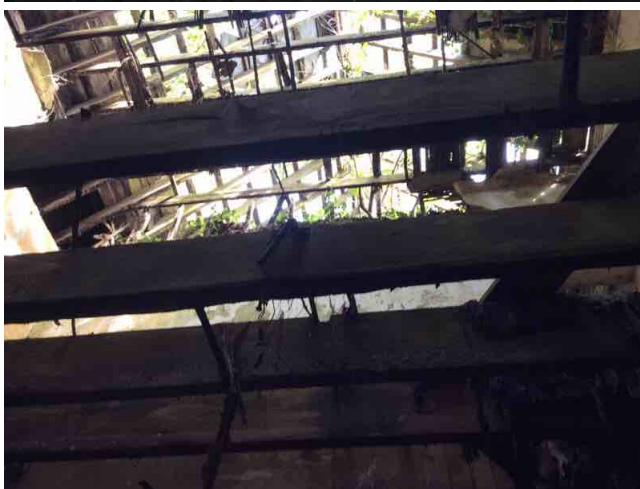
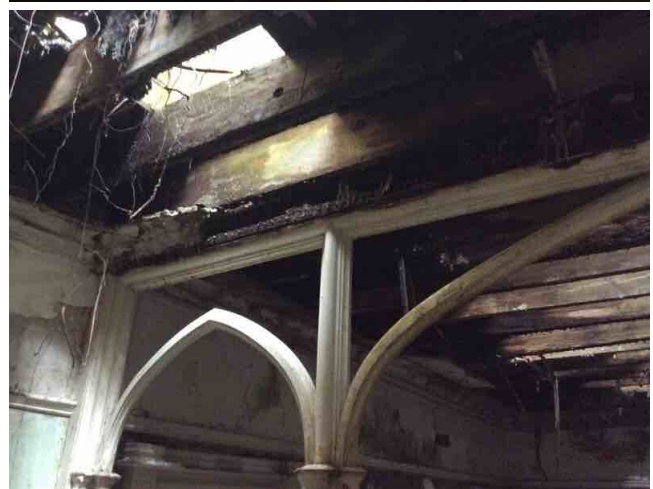
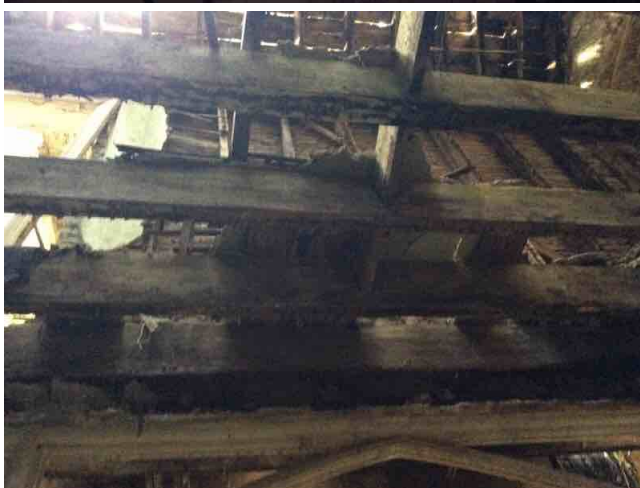
3 08/06/2021

Photographic record of internal ground floor area. No suspect asbestos containing materials found.

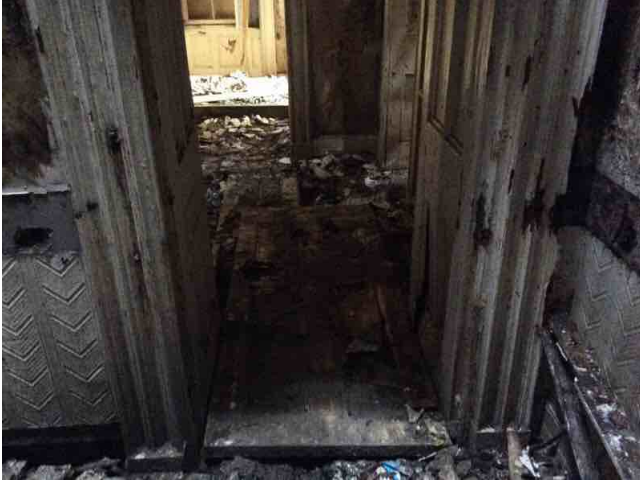
4 08/06/2021

Photographic record of internal ground floor area. No suspect asbestos containing materials found.

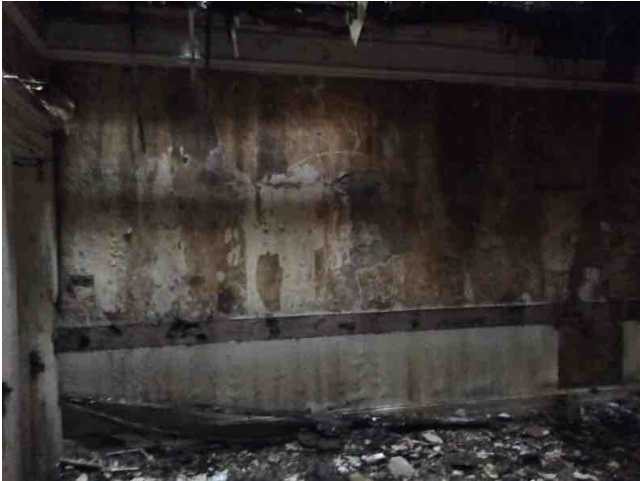
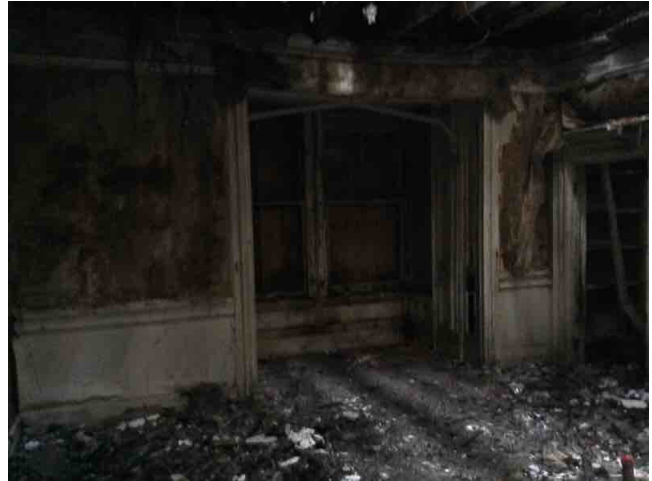
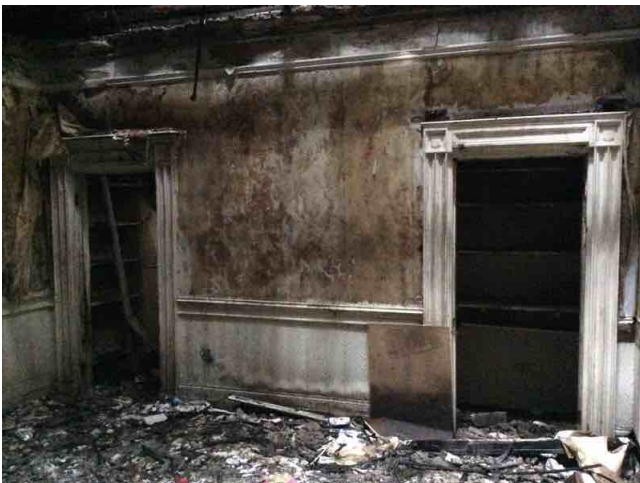
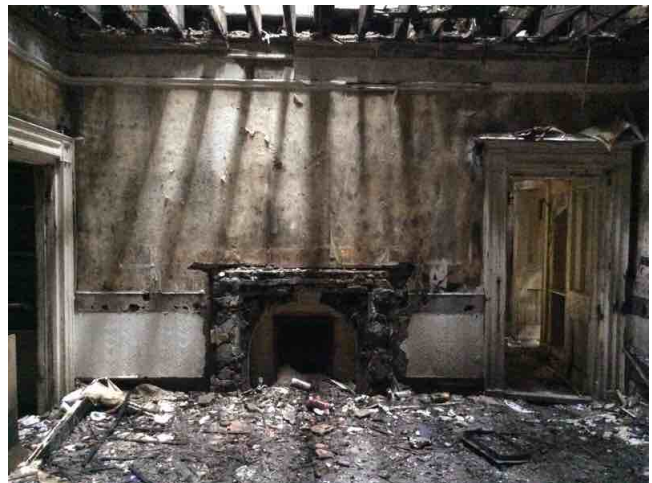
5 + 08/06/2021

Photographic records taken from ground floor of features on the first floor. For safety reasons, access to the first floor was not possible.

As the materials of construction appear to be consistent throughout the house, the presence of asbestos containing materials is very unlikely.

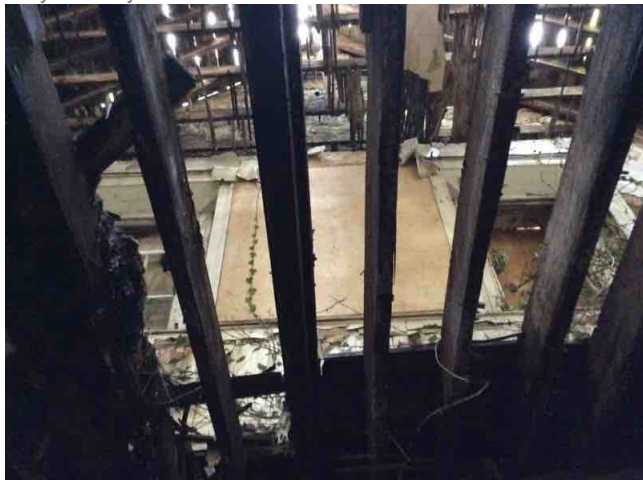
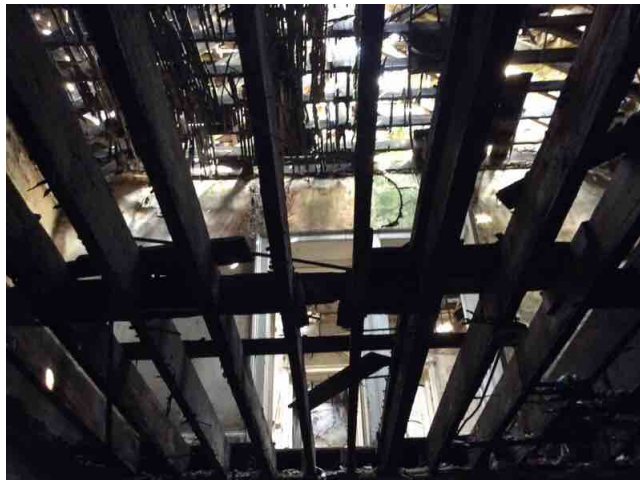
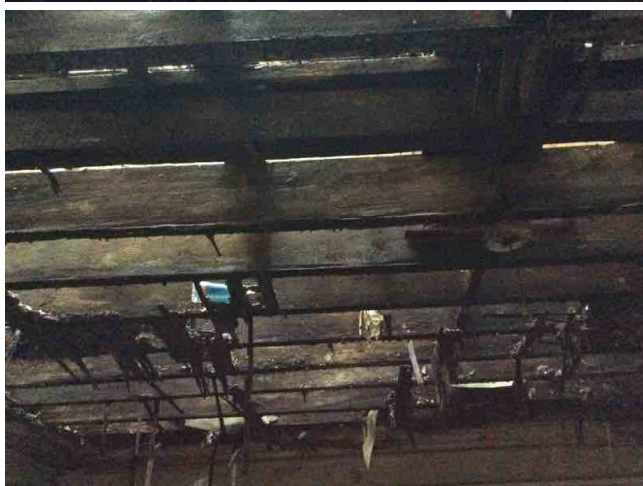
6 + 08/06/2021

Photographic records taken from ground floor of features on the first floor. For safety reasons, access to the first floor was not possible.

As the materials of construction appear to be consistent throughout the house, the presence of asbestos containing materials is very unlikely.

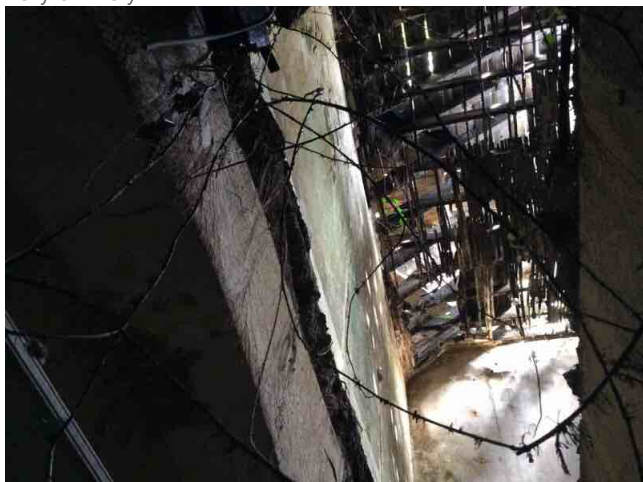
7 08/06/2021

Photographic record of internal ground floor area. No suspect asbestos containing materials found.

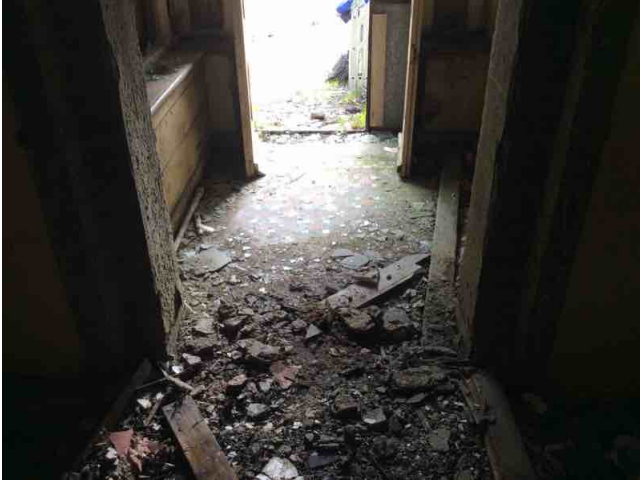
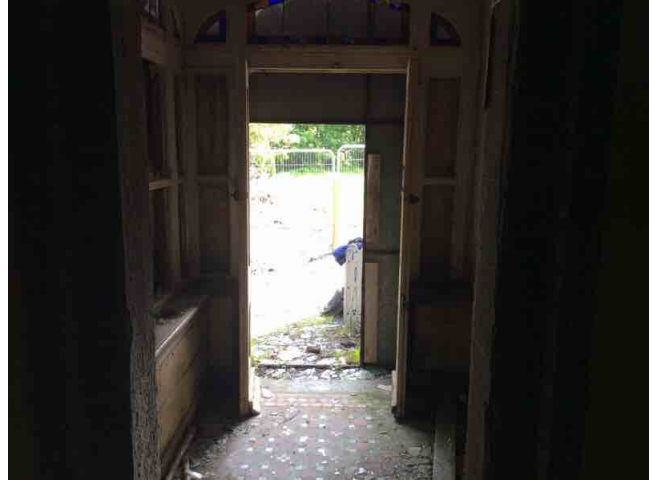
8 + 08/06/2021

Photographic record of internal ground floor area. No suspect asbestos containing materials found.

Photographic records taken from ground floor of features on the first floor. For safety reasons, access to the first floor was not possible.

As the materials of construction appear to be consistent throughout the house, the presence of asbestos containing materials is very unlikely.

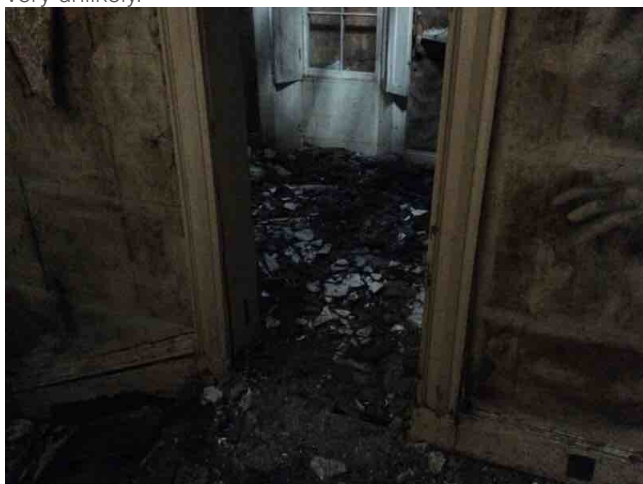
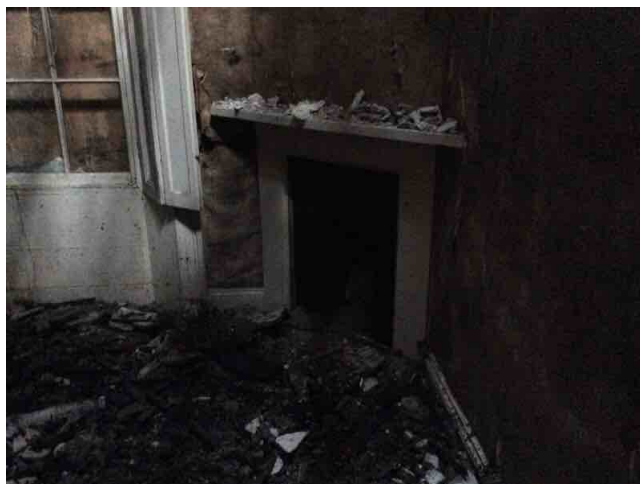
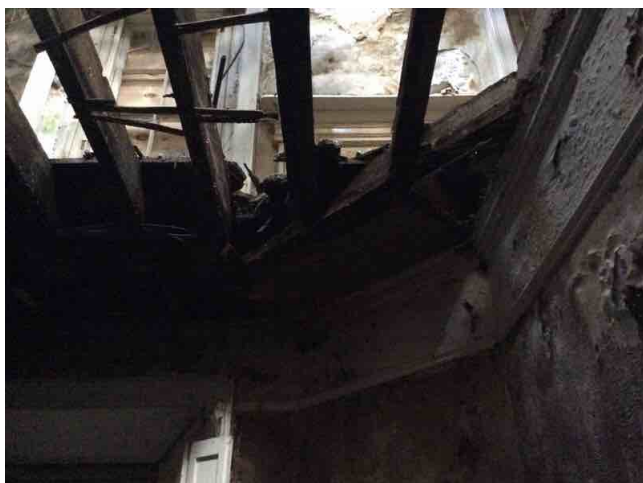
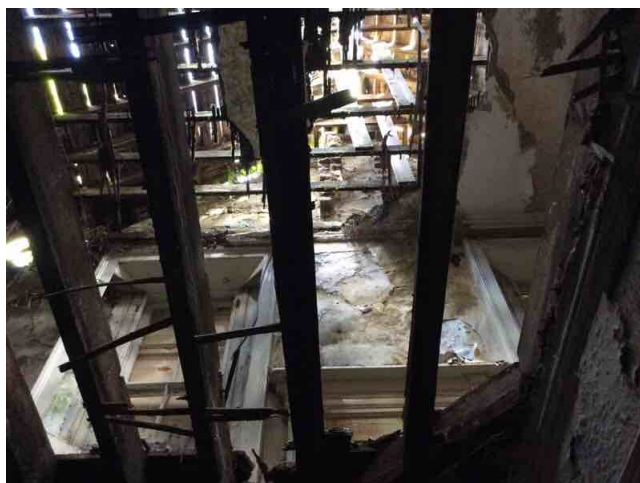
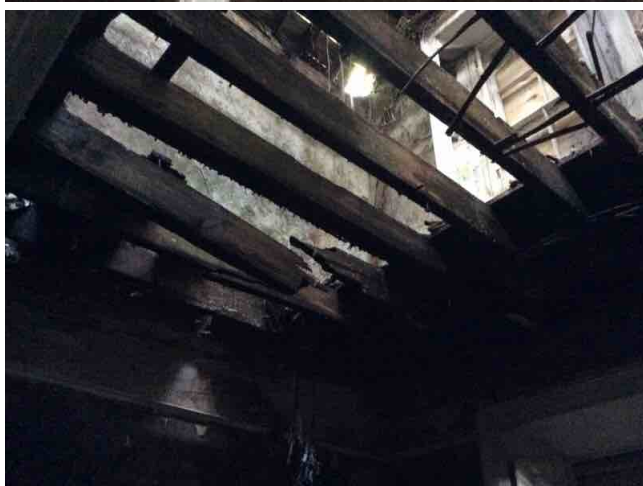
9 + 08/06/2021

Photographic records taken from ground floor of features on the stairs. For safety reasons, access to the first floor was not possible.

As the materials of construction appear to be consistent throughout the house, the presence of asbestos containing materials is very unlikely.

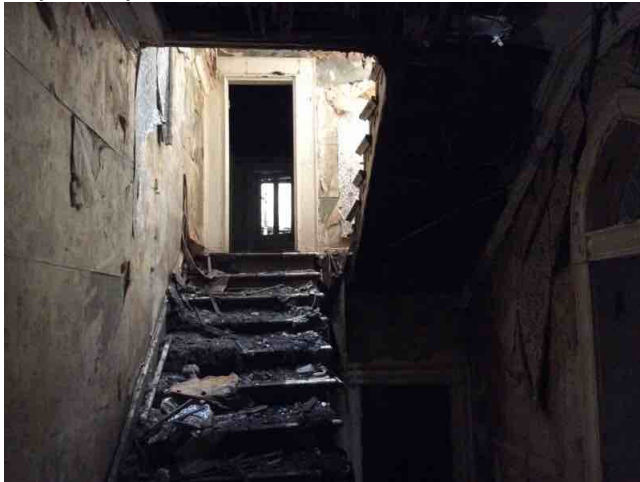
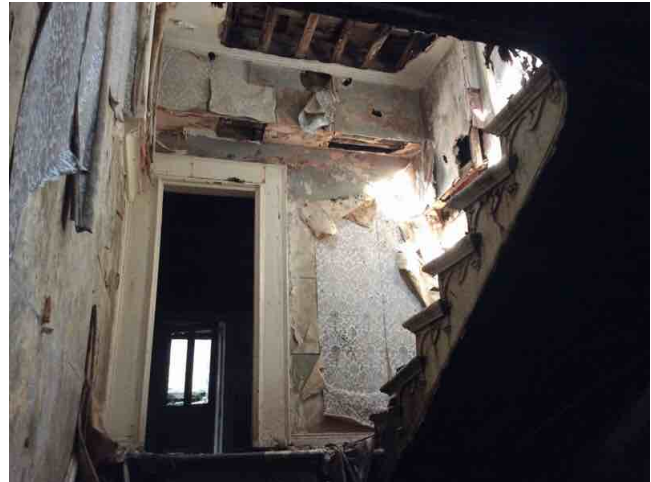
10 + 08/06/2021

Photographic record of internal ground floor area. No suspect asbestos containing materials found.

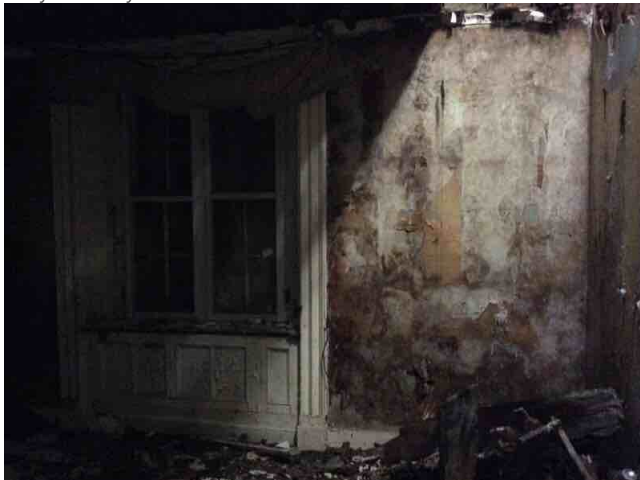
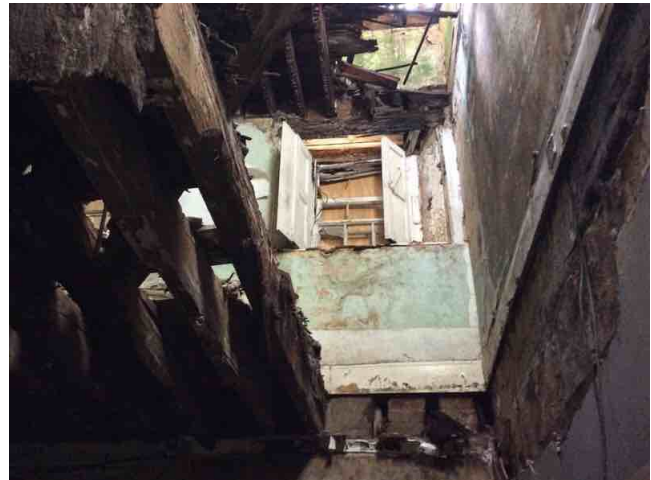
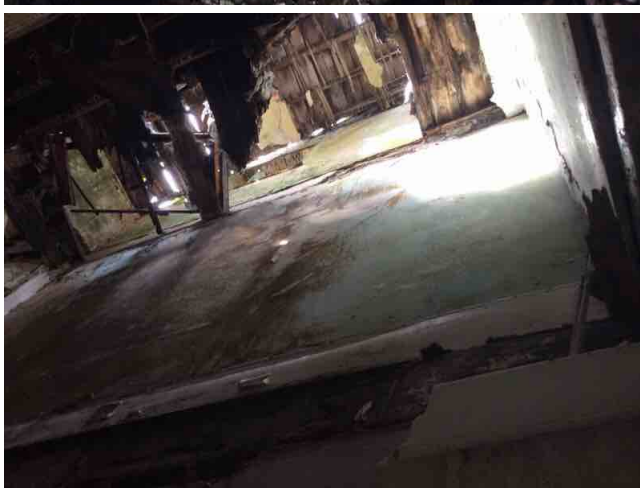
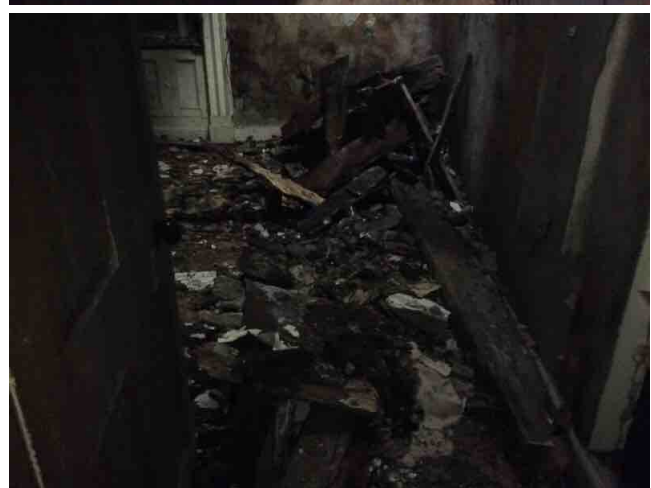
11 08/06/2021

Photographic record of internal ground floor area. No suspect asbestos containing materials found.

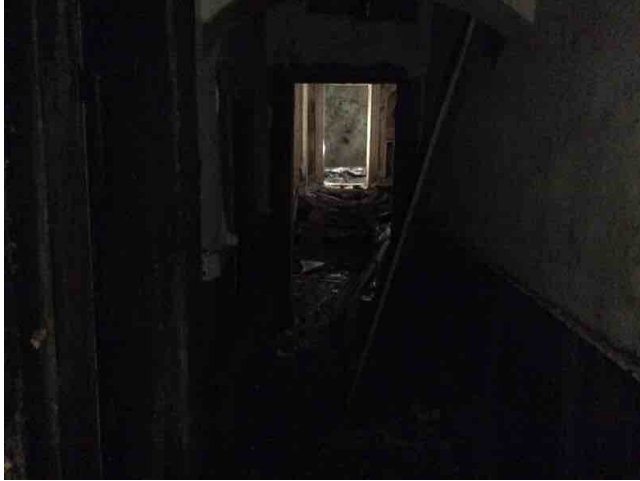
12 + 08/06/2021

Photographic record of internal ground floor area. No suspect asbestos containing materials found.

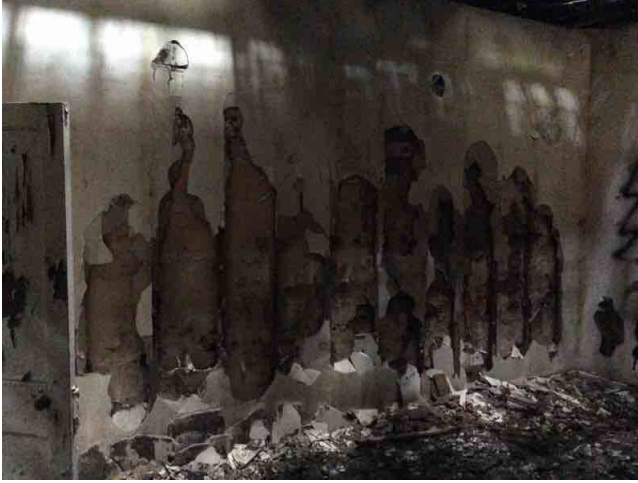
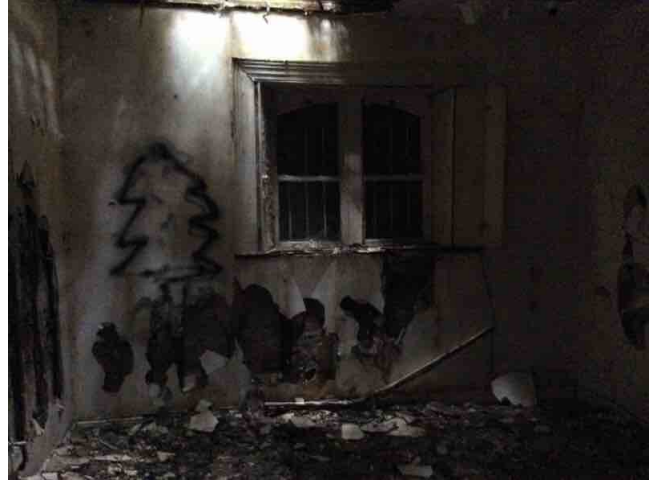
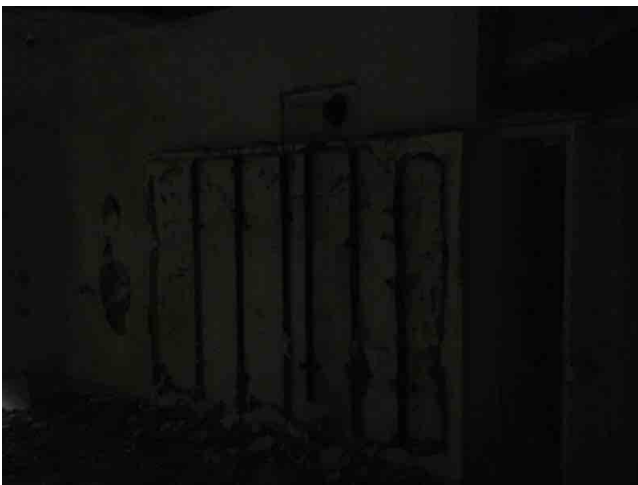
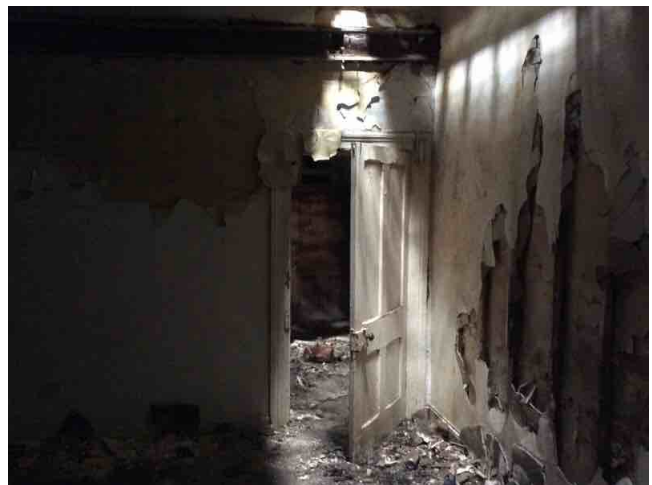
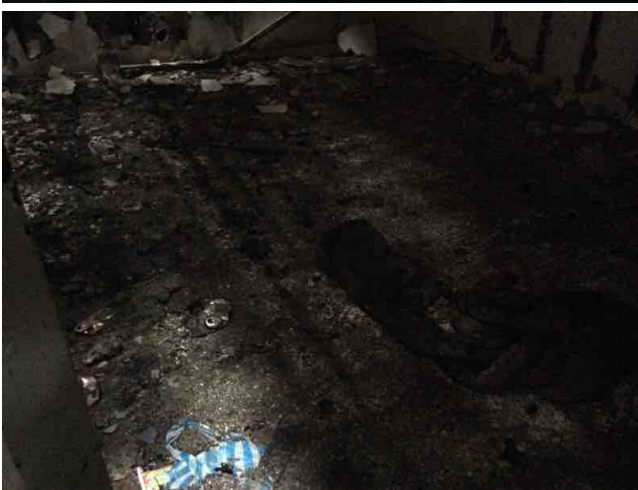
**13** + 08/06/2021

Photographic record of internal ground floor area. No suspect asbestos containing materials found.

Photographic records taken from ground floor of features on the first floor. For safety reasons, access to the first floor was not possible.

As the materials of construction appear to be consistent throughout the house, the presence of asbestos containing materials is very unlikely.

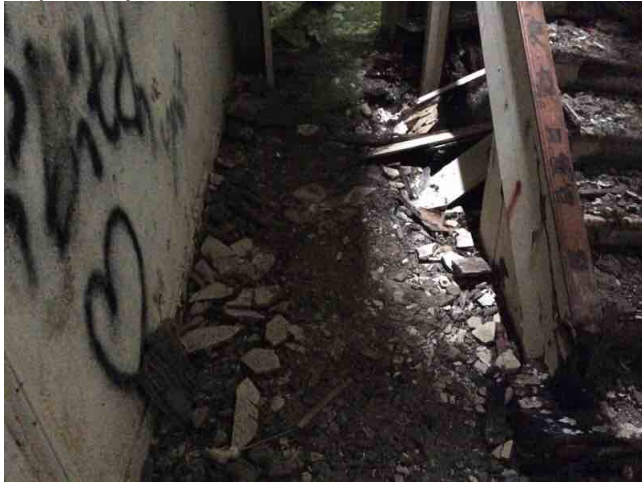
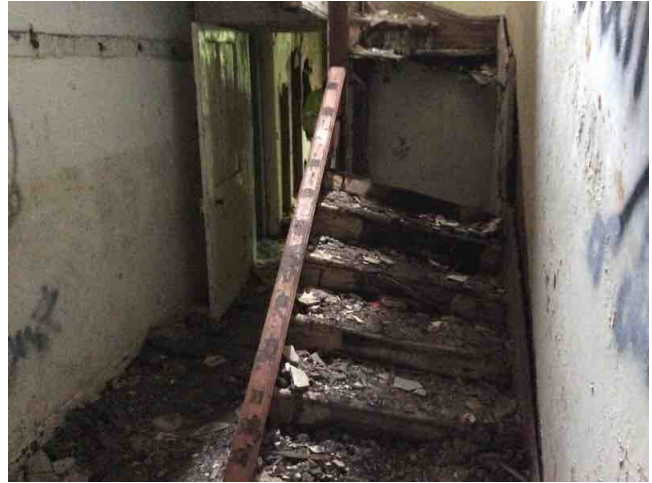
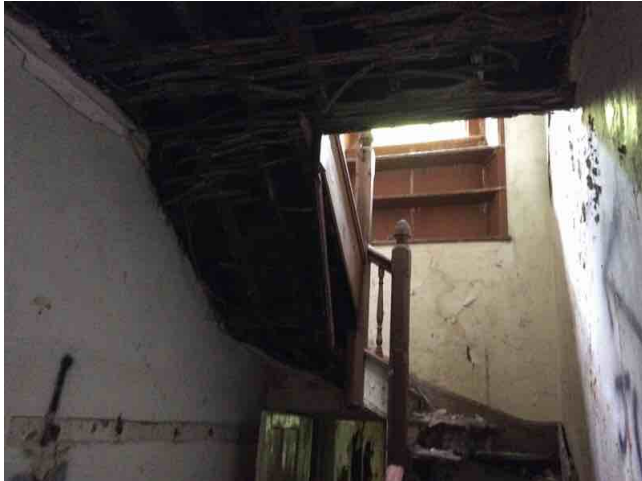
**16** + 08/06/2021

This room is full of rubbish and therefore inaccessible during the survey.

As the materials of construction within the room appear to be consistent with other areas of the house, the presence of asbestos containing materials is very unlikely.
